Historic Asbestos-Containing Materials Data
University of Toronto Scarborough
Bladen Wing and Academic Resource Centre

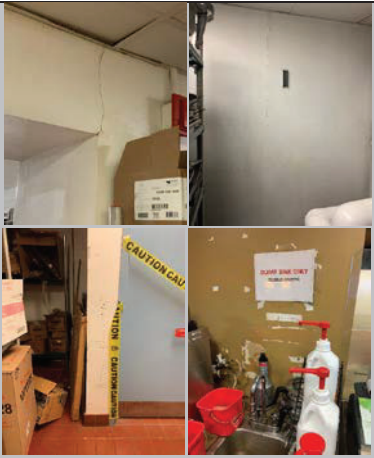
NEW 2'X4' LAY-IN CEILING TILES							NO				NOT SUSPECTED TO CONTAIN ASBESTOS		N/A
		NEW DRYWALL CEILING							NO				NOT SUSPECTED TO CONTAIN ASBESTOS		N/A
		DRYWALL JOINT COMPOUND	DRYWALL JOINT COMPOUND	WALL	7 SQ. FT.	R-SA66	0.5	CHRYSTOTILE	YES	POOR	A	NON-FRIABLE	THE DAMAGED DRYWALL FINISH SHOULD BE REPAIRED FOLLOWING TYPE 1 ASBESTOS PROCEDURES, AS PRESCRIBED UNDER O.REG. 278/05.

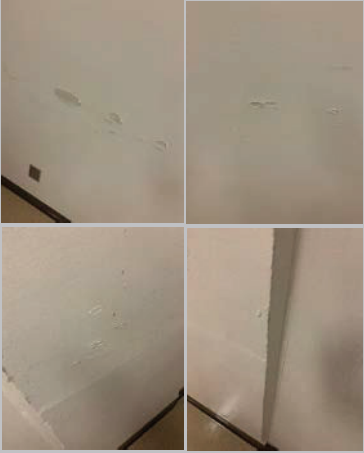
NEW VINYL SHEET FLOORING							NO				NOT SUSPECTED TO CONTAIN ASBESTOS		N/A
B359	CLASSROOM	DRYWALL JOINT COMPOUND	DRYWALL JOINT COMPOUND	WALL	400 SQ. FT	R-SA21 (A-C)-08	1.75	CHRYSTILE	YES	GOOD	A	NON-FRIABLE			4
		NEW 2'X4' LAY-IN CEILING TILES							NO				NOT SUSPECTED TO CONTAIN ASBESTOS		N/A
		VINYL FLOOR TILE	12"X12" RED FLOOR TILES	FLOOR BELOW CARPET	1165 SQ. FT	R-SA65	5	CHRYSTILE	YES	GOOD	A	NON-FRIABLE	CARPET OBSERVED THROUGHOUT THE ROOM. ASBESTOS FLOOR TILES MAY STILL BE PRESENT BENEATH THE CARPET.		4
B360	CLASSROOM	DRYWALL JOINT COMPOUND	DRYWALL JOINT COMPOUND	WALL	400 SQ. FT	R-SA21 (A-C)-08	1.75	CHRYSTILE	YES	GOOD	A	NON-FRIABLE			N/A
		NEW VINYL SHEET FLOORING							NO				NOT SUSPECTED TO CONTAIN ASBESTOS		N/A
B361	CLASSROOM	DRYWALL JOINT COMPOUND	DRYWALL JOINT COMPOUND	WALL	200 SQ. FT	R-SA21 (A-C)-08	1.75	CHRYSTILE	YES	GOOD	A	NON-FRIABLE			4
		DRYWALL JOINT COMPOUND	DRYWALL JOINT COMPOUND	WALL	4 SQ. FT.	R-SA21 (A-C)-08	1.75	CHRYSTILE	YES	POOR	A	NON-FRIABLE	THE DAMAGED ASBESTOS-CONTAINING DRYWALL FINISH SHOULD BE REPAIRED FOLLOWING TYPE 1 ASBESTOS PROCEDURES, AS PRESCRIBED UNDER O.REG. 278/05.

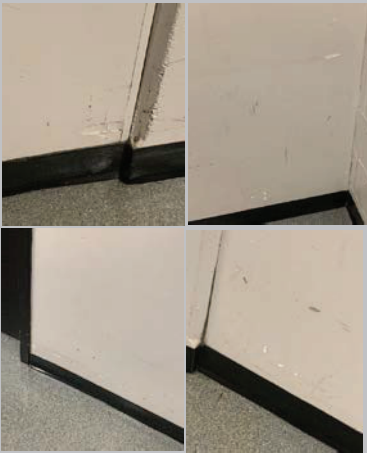
Room Number	Area	Material	Description	Location	Qty/Unit	Sample Number	%	Type	ACM (Yes, No, Suspect)	Condition	Accessibility	Friability	Comments	Photograph of Damaged ACM	Action Required
B369K	CORRIDOR	PARGING CEMENT ON PIPE FITTINGS	FITTINGS	GENERAL ROOM	9	R-SA60	50-75	CHRYSTOTILE	YES	GOOD	C	FRIABLE			4
		DRYWALL JOINT COMPOUND	DRYWALL JOINT COMPOUND	WALL	300 SQ. FT.	SA21(A-C)-08	1.75	CHRYSTOTILE	YES	GOOD	A	NON-FRIABLE			4
		DRYWALL JOINT COMPOUND	DRYWALL JOINT COMPOUND	WALL	3 SQ. FT.	SA21(A-C)-08	1.75	CHRYSTOTILE	YES	POOR	A	NON-FRIABLE	THE DAMAGED ASBESTOS-CONTAINING DRYWALL FINISH SHOULD BE REPAIRED FOLLOWING TYPE 1 ASBESTOS PROCEDURES, AS PRESCRIBED UNDER O.REG. 278/05.

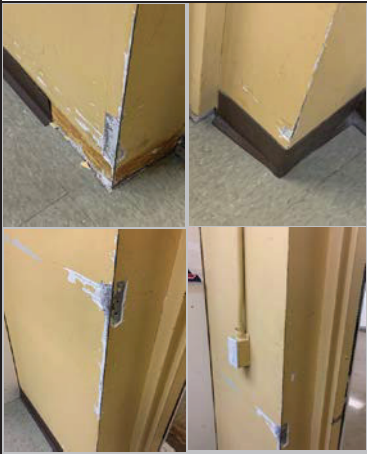
Room Number	Area	Material	Description	Location	Qty/Unit	Sample Number	%	Type	ACM (Yes, No, Suspect)	Condition	Accessibility	Friability	Comments	Photograph of Damaged ACM	Action Required
B390D	BOOK STORE	DRYWALL JOINT COMPOUND	DRYWALL JOINT COMPOUND	WALL	1500 SQ. FT.	R-SA68	0.5	CHRYSTILE	YES	GOOD	A	NON-FRIABLE	MATERIAL HAS BEEN PREVIOUSLY SAMPLED BY MAPLE AND WAS FOUND NOT TO CONTAIN ASBESTOS, HOWEVER ADDITIONAL SAMPLING IS RECOMMENDED.		4
		DRYWALL JOINT COMPOUND	DRYWALL JOINT COMPOUND	WALL	8 SQ. FT.	R-SA68	0.5	CHRYSTILE	YES	POOR	A	NON-FRIABLE	THE DAMAGED ASBESTOS-CONTAINING DRYWALL FINISH SHOULD BE REPAIRED FOLLOWING TYPE 1 ASBESTOS PROCEDURES, AS PRESCRIBED UNDER O.REG. 278/05.

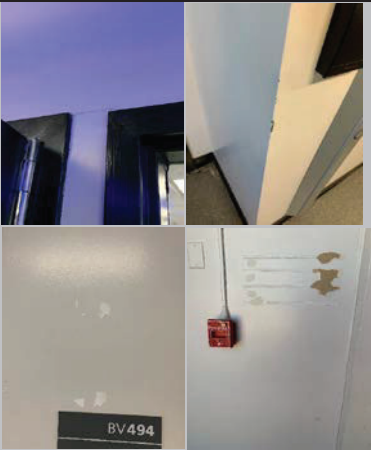
Room Number	Area	Material	Description	Location	Qty/Unit	Sample Number	%	Type	ACM (Yes, No, Suspect)	Condition	Accessibility	Friability	Comments	Photograph of Damaged ACM	Action Required
B400K	CORRIDOR	DRYWALL JOINT COMPOUND	DRYWALL JOINT COMPOUND	WALL	200 SQ. FT.	R-SA68	0.5	CHRYSTILE	YES	GOOD	A	NON-FRIABLE			
		DRYWALL JOINT COMPOUND	DRYWALL JOINT COMPOUND	WALL	10 SQ. FT.	R-SA68	0.5	CHRYSTILE	YES	POOR	A	NON-FRIABLE	THE DAMAGED ASBESTOS-CONTAINING DRYWALL FINISH SHOULD BE REPAIRED FOLLOWING TYPE 1 ASBESTOS PROCEDURES, AS PRESCRIBED UNDER O.REG. 278/05.

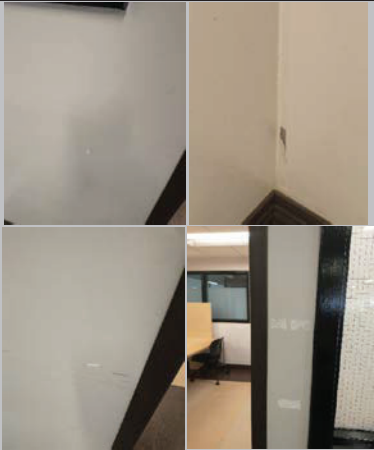
Room Number	Area	Material	Description	Location	Qty/Unit	Sample Number	%	Type	ACM (Yes, No, Suspect)	Condition	Accessibility	Friability	Comments	Photograph of Damaged ACM	Action Required
B428K	CORRIDOR	DRYWALL JOINT COMPOUND	DRYWALL JOINT COMPOUND	WALLS	300 SQ. FT	SA23(A-G)-08	2.25	CHRYSTILE	YES	GOOD	A	NON-FRIABLE			4
		PARGING CEMENT ON PIPE FITTINGS	FITTINGS	GENERAL ROOM	25	R-SA60	50-75	CHRYSTILE	YES	GOOD	C	FRIABLE			4
		DRYWALL JOINT COMPOUND	DRYWALL JOINT COMPOUND	WALL	2 SQ. FT.	SA23(A-G)-08	2.25	CHRYSTILE	YES	POOR	A	NON-FRIABLE	THE DAMAGED ASBESTOS-CONTAINING DRYWALL FINISH SHOULD BE REPAIRED FOLLOWING TYPE 1 ASBESTOS PROCEDURES, AS PRESCRIBED UNDER O.REG. 278/05.

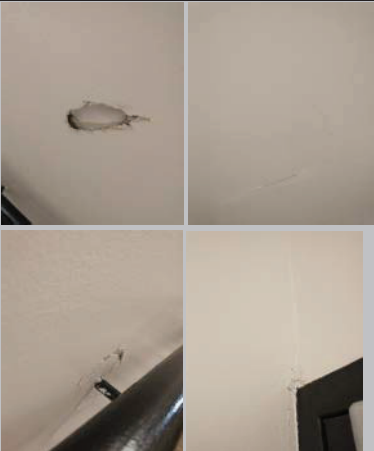
NEW VINYL SHEET FLOORING							NO				NOT SUSPECTED TO CONTAIN ASBESTOS		N/A
B428S	STAIRWELL	PARGING CEMENT ON PIPE FITTINGS	FITTINGS	GENERAL ROOM	7	R-SA60	50-75	CHRYSTILE	YES	GOOD	C	FRIABLE			4
		DRYWALL JOINT COMPOUND	DRYWALL JOINT COMPOUND	WALL	1500 SQ. FT.	R-SA23(A-G)-08	2.25	CHRYSTILE	YES	GOOD	A	NON-FRIABLE			4
		DRYWALL JOINT COMPOUND	DRYWALL JOINT COMPOUND	WALL	1 SQ. FT.	R-SA23(A-G)-08	2.25	CHRYSTILE	YES	POOR	A	NON-FRIABLE	THE DAMAGED ASBESTOS-CONTAINING DRYWALL FINISH SHOULD BE REPAIRED FOLLOWING TYPE 1 ASBESTOS PROCEDURES, AS PRESCRIBED UNDER O.REG. 278/05.

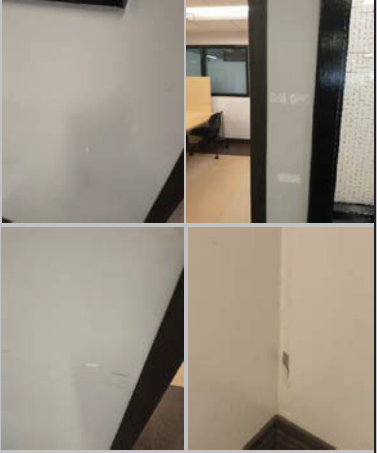
Room Number	Area	Material	Description	Location	Qty/Unit	Sample Number	%	Type	ACM (Yes, No, Suspect)	Condition	Accessibility	Friability	Comments	Photograph of Damaged ACM	Action Required
B430K	CORRIDOR	NEW FIBREGLASS INSULATION	FITTINGS	GENERAL ROOM					NO				PREVIOUSLY IDENTIFIED ASBESTOS-CONTAINING PARGING CEMENT OBSERVED TO BE REPLACED WITH FIBERGLASS INSULATION AND COVERED IN PVC		N/A
		DRYWALL JOINT COMPOUND	DRYWALL JOINT COMPOUND	WALLS	2000 SQ. FT	SA23(A-G)-08	2.25	CHRYSTOTILE	YES	GOOD	A	NON-FRIABLE			4
		DRYWALL JOINT COMPOUND	DRYWALL JOINT COMPOUND	WALLS	3 SQ. FT.	SA23(A-G)-08	2.25	CHRYSTOTILE	YES	POOR	A	NON-FRIABLE	THE DAMAGED ASBESTOS-CONTAINING DRYWALL FINISH SHOULD BE REPAIRED FOLLOWING TYPE 1 ASBESTOS PROCEDURES, AS PRESCRIBED UNDER O.REG. 278/05.

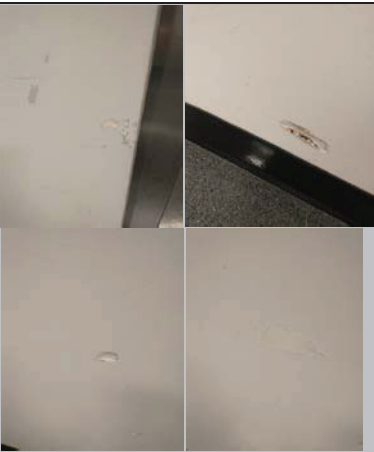
Room Number	Area	Material	Description	Location	Qty/Unit	Sample Number	%	Type	ACM (Yes, No, Suspect)	Condition	Accessibility	Friability	Comments	Photograph of Damaged ACM	Action Required
B478	ELECTRICAL	DRYWALL JOINT COMPOUND	DRYWALL JOINT COMPOUND	WALL/CEILING	150 SQ. FT.	R-SA24(A-C)-08	1.25	CHRYSTILE	YES	GOOD	B	NON-FRIABLE			4
		CAULKING	GREY CAULKING	EXTERIOR CAULKING (ON ROOF)		27295-4A-C		ND	NO				SAMPLED BY OHE IN 2021 (OHE PROJECT #27295). TO VIEW PROJECT-SPECIFIC REPORTS, SEE FACILITIES AND/OR HEALTH & SAFETY.		N/A
		PARGING CEMENT ON PIPE FITTINGS	FITTINGS	GENERAL ROOM	18	R-SA60	50-75	CHRYSTILE	YES	GOOD	B	FRIABLE	AREA/ROOM RECENTLY RENOVATED		4
B478K	CORRIDOR	DRYWALL JOINT COMPOUND	DRYWALL JOINT COMPOUND	WALL	300 SQ. FT.	25622-024-6A-C	2	CHRYSTILE	YES	GOOD	A	NON-FRIABLE			4
		DRYWALL JOINT COMPOUND	DRYWALL JOINT COMPOUND	WALL	3 SQ. FT.	25622-024-6A-C	2	CHRYSTILE	YES	POOR	A	NON-FRIABLE	SAMPLED BY OHE IN 2022 (PROJECT 25622-024). THE DAMAGED ASBESTOS-CONTAINING DRYWALL FINISH SHOULD BE REPAIRED FOLLOWING TYPE 1 ASBESTOS PROCEDURES, AS PRESCRIBED UNDER O.REG. 278/05.

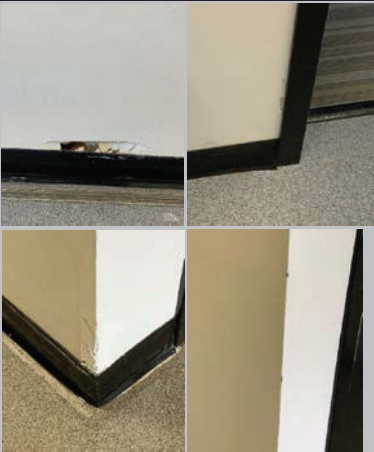
B500	OFFICE	NEW VINYL SHEET FLOORING	NEW 2009	FLOOR					NO				VINYL SHEET FLOORING IS NOW OVERLAIN BY 2'X2' CARPET TILE FLOORING. THIS RENOVATION REPORTEDLY TOOK PLACE EARLY IN 2012.		N/A
		DRYWALL JOINT COMPOUND	DRYWALL JOINT COMPOUND	WALL	500 SQ. FT.	R-SA68	0.5	CHRYSTOTILE	YES	GOOD	A	NON-FRIABLE			4
B500E	ELEVATOR	NO SUSPECT ACM OBSERVED							NO						N/A
		NEW VINYL SHEET FLOORING	NEW 2009	FLOOR					NO						N/A
B500K	CORRIDOR	DRYWALL JOINT COMPOUND	DRYWALL JOINT COMPOUND	WALL	678 SQ. FT.	R-SA68	0.5	CHRYSTOTILE	YES	GOOD	A	NON-FRIABLE			4
		DRYWALL JOINT COMPOUND	DRYWALL JOINT COMPOUND	WALL	10 SQ. FT.	R-SA68	0.5	CHRYSTOTILE	YES	POOR	A	NON-FRIABLE	THE DAMAGED ASBESTOS-CONTAINING DRYWALL FINISH SHOULD BE REPAIRED FOLLOWING TYPE 1 ASBESTOS PROCEDURES, AS PRESCRIBED UNDER O.REG. 278/05.

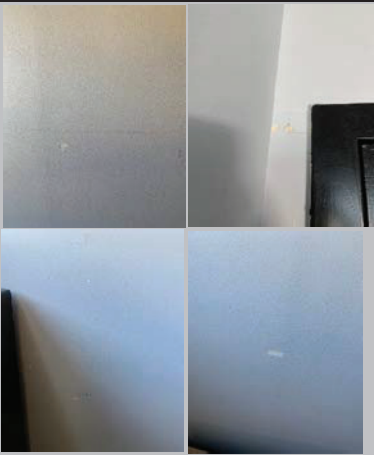
B512	OFFICE	DRYWALL JOINT COMPOUND	DRYWALL JOINT COMPOUND	WALL	2 SQ. FT	R-SA68 & S07C	2	CHRYSTOTILE	YES	POOR	A	NON-FRIABLE	THE DAMAGED ASBESTOS-CONTAINING DRYWALL FINISH SHOULD BE REPAIRED FOLLOWING TYPE 1 ASBESTOS PROCEDURES, AS PRESCRIBED UNDER O.REG. 278/05.

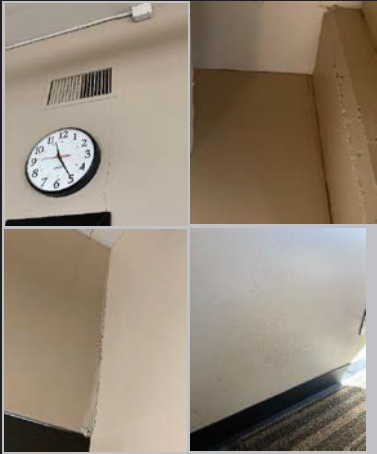
B540	BOARDROOM	DRYWALL JOINT COMPOUND	DRYWALL JOINT COMPOUND	WALL	6 L. FT.	R-SA68	0.5	CHRYSTOTILE	YES	FAIR	A	NON-FRIABLE	THE DAMAGED ASBESTOS-CONTAINING DRYWALL FINISH SHOULD BE REPAIRED FOLLOWING TYPE 1 ASBESTOS PROCEDURES, AS PRESCRIBED UNDER O.REG. 278/05.

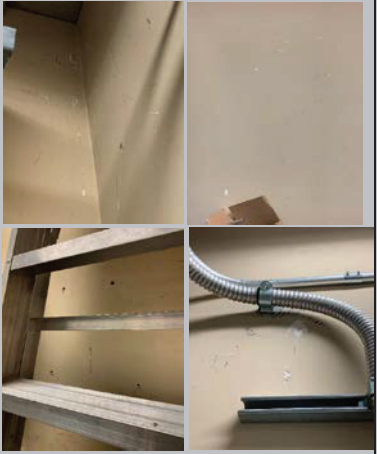
Room Number	Area	Material	Description	Location	Qty/Unit	Sample Number	%	Type	ACM (Yes, No, Suspect)	Condition	Accessibility	Friability	Comments	Photograph of Damaged ACM	Action Required
B578	OFFICE	NEW VINYL SHEET FLOORING							NO				NOT SUSPECTED TO CONTAIN ASBESTOS		N/A
		DRYWALL JOINT COMPOUND	DRYWALL JOINT COMPOUND	WALL	200 SQ. FT	R-SA68	0.5	CHRYSTOTILE	YES	GOOD	A	NON-FRIABLE			4
B580	ELECTRICAL	PARGING CEMENT ON PIPE FITTINGS	FITTINGS	GENERAL ROOM	8	R-SA60	50-75	CHRYSTOTILE	YES	GOOD	B/C	FRIABLE			4
		DRYWALL JOINT COMPOUND	DRYWALL JOINT COMPOUND	WALL	150 SQ. FT	R-SA68	0.5	CHRYSTOTILE	YES	GOOD	B	NON-FRIABLE			4
		DRYWALL JOINT COMPOUND	DRYWALL JOINT COMPOUND	WALL	2 SQ. FT.	R-SA68	0.5	CHRYSTOTILE	YES	POOR	B	NON-FRIABLE	THE DAMAGED ASBESTOS-CONTAINING DRYWALL FINISH SHOULD BE REPAIRED FOLLOWING TYPE 1 ASBESTOS PROCEDURES, AS PRESCRIBED UNDER O.REG. 278/05.

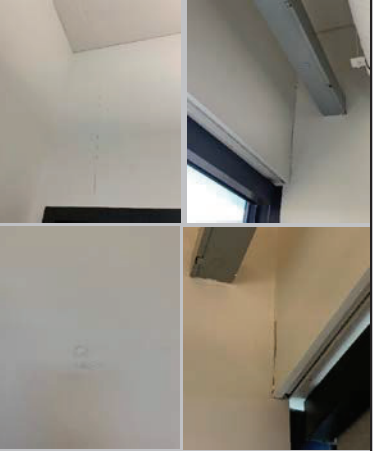
Room Number	Area	Material	Description	Location	Qty/Unit	Sample Number	%	Type	ACM (Yes, No, Suspect)	Condition	Accessibility	Friability	Comments	Photograph of Damaged ACM	Action Required
B586	OFFICE	DRYWALL JOINT COMPOUND	DRYWALL JOINT COMPOUND	WALL	460 SQ. FT	R-SA68	0.5	CHRYSTILE	YES	GOOD	A	NON-FRIABLE	MONITOR MINOR CRACKS
