Historic Asbestos-Containing Materials Data  
University of Toronto Scarborough  
Humanities Wing

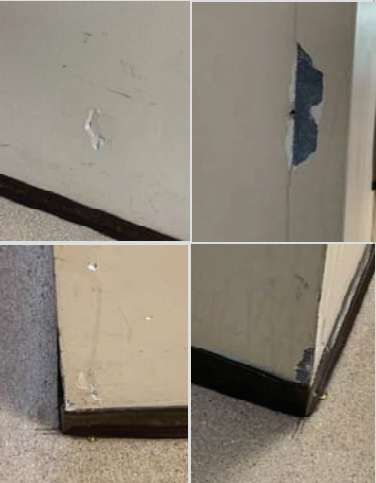
Room Number	Area #	Material	Description	Location	Qty/Unit	SA#	%	Type	Condition	ACM (Yes, No, Suspect)	Accessibility	Friability	Comments	Photographs	Action Required
H316V	VESTIBULE	DRYWALL	DRYWALL JOINT COMPOUND	WALL	400 SQ. FT.	25622-023-1A-C	1	CHRYSTILE	GOOD	YES	A	NON-FRIABLE	SAMPLED BY OHE (PROJECT 25622-023) IN 2022.		4
		DRYWALL	DRYWALL JOINT COMPOUND	WALL	7 SQ. FT.	25622-023-1A-C	1	CHRYSTILE	POOR	YES	A	NON-FRIABLE	SAMPLED BY OHE (PROJECT 25622-023) IN 2022. THE DAMAGED ASBESTOS-CONTAINING DRYWALL SHOULD BE REPAIRED FOLLOWING TYPE 1 ASBESTOS PROCEDURES, AS PRESCRIBED UNDER O.REG. 278/05.
