Historic Asbestos Containing Materials Data
University of Toronto Scarborough
Phase 1 and Phase 2 Residences

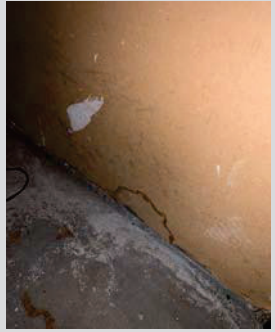
Unit#	Area	Material	Description	Location	Qty/Unit	Sample Number	%	Type	ACM (Yes, No, Suspect)	Condition	Accessibility	Friability	Comments	Photograph of Damaged ACM	Action Required
A2	THROUGHOUT	DRYWALL JOINT COMPOUND	WHITE DRYWALL JOINT COMPOUND	WALLS AND CEILINGS	3490 SQ. FT.	P1-1a (2010 Report)	1.5	CHRYSTILE	YES	GOOD	A	NON-FRIABLE			4
	THROUGHOUT	LIGHT FIXTURE	HEAT SHIELD PAPER	THROUGHOUT BUILDING	UNKNOWN	NOT SAMPLED	N/A	PRESUMED	PRESUMED	GOOD	D	FRIABLE	PRESUMED ACM, NOT PREVIOUSLY SAMPLED		4
	BASEMENT	DRYWALL JOINT COMPOUND	WATER DAMAGED	WALL	6 SQ. FT.	P1-1a (2010 Report)	1.5	CHRYSTILE	YES	POOR	A	NON-FRIABLE	THE DAMAGED DRYWALL WITH ASBESTOS-CONTAINING DRYWALL JOINT COMPOUND SHOULD BE REPAIRED FOLLOWING TYPE 1 ASBESTOS PROCEDURES, AS PRESCRIBED UNDER O. REG. 278/05 IN CONJUNCTION WITH EACC LEVEL 1 MOULD PROCEDURES.

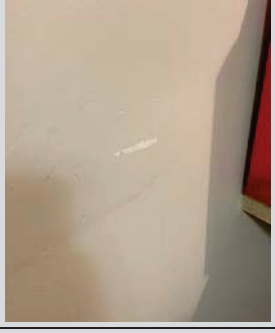
2
	KITCHEN	DRYWALL JOINT COMPOUND	DAMAGED DRYWALL	WALL ADJACENT TO KITCHEN TABLE	4 SQ. FT.	P1-1a (2010 Report)	1.5	CHRYSTILE	YES	POOR	A	NON-FRIABLE	THE DAMAGED DRYWALL WITH ASBESTOS-CONTAINING DRYWALL JOINT COMPOUND SHOULD BE REPAIRED FOLLOWING TYPE 1 ASBESTOS PROCEDURES, AS PRESCRIBED UNDER O. REG. 278/05.

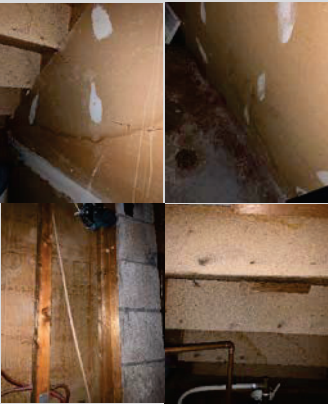
BASEMENT	DRYWALL JOINT COMPOUND	WATER DAMAGED	WALL	10 SQ. FT.	P1-1a (2010 Report)	1.5	CHRYSTILE	YES	POOR	A	NON-FRIABLE	THE DAMAGED ASBESTOS-CONTAINING DRYWALL JOINT COMPOUND SHOULD BE REPAIRED FOLLOWING TYPE 2 ASBESTOS PROCEDURES, AS PRESCRIBED UNDER O. REG. 278/05 IN CONJUNCTION WITH EACC LEVEL 1 MOULD PROCEDURES.

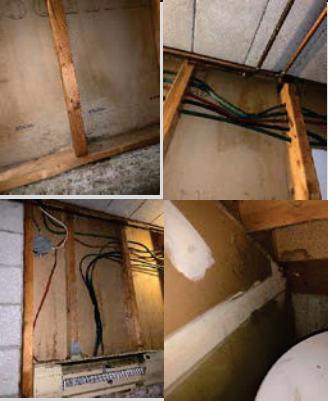
Unit#	Area	Material	Description	Location	Qty/Unit	Sample Number	%	Type	ACM (Yes, No, Suspect)	Condition	Accessibility	Friability	Comments	Photograph of Damaged ACM	Action Required
A7	BASEMENT	DRYWALL JOINT COMPOUND	WATER DAMAGED	WALL	50 SQ. FT.	P1-1a (2010 Report)	1.5	CHRYSTILE	YES	POOR	A	NON-FRIABLE	THE DAMAGED ASBESTOS-CONTAINING DRYWALL JOINT COMPOUND SHOULD BE REPAIRED FOLLOWING TYPE 2 ASBESTOS PROCEDURES, AS PRESCRIBED UNDER O. REG. 278/05 IN CONJUNCTION WITH EACC LEVEL 1 MOULD PROCEDURES.

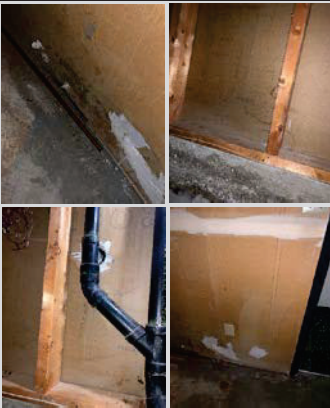
Unit#	Area	Material	Description	Location	Qty/Unit	Sample Number	%	Type	ACM (Yes, No, Suspect)	Condition	Accessibility	Friability	Comments	Photograph of Damaged ACM	Action Required
BIRCH HALL															
B1	THROUGHOUT	DRYWALL JOINT COMPOUND	WHITE DRYWALL JOINT COMPOUND	WALLS AND CEILINGS	3490 SQ. FT.	P1-1a (2010 Report)	1.5	CHRYSTILE	YES	GOOD	A	NON-FRIABLE			4
	THROUGHOUT	LIGHT FIXTURE	HEAT SHIELD PAPER	THROUGHOUT BUILDING	UNKNOWN	NOT SAMPLED	N/A	PRESUMED	PRESUMED	GOOD	D	FRIABLE	PRESUMED ACM, NOT PREVIOUSLY SAMPLED		4
	BASEMENT	DRYWALL JOINT COMPOUND	WATER DAMAGED AND MOULD IMPACTED WALL	WALL	7 SQ. FT.	P1-1a (2010 Report)	1.5	CHRYSTILE	YES	POOR	A	NON-FRIABLE	THE DAMAGED DRYWALL WITH ASBESTOS-CONTAINING DRYWALL JOINT COMPOUND SHOULD BE REPAIRED FOLLOWING TYPE 1 ASBESTOS PROCEDURES, AS PRESCRIBED UNDER O. REG. 278/05.

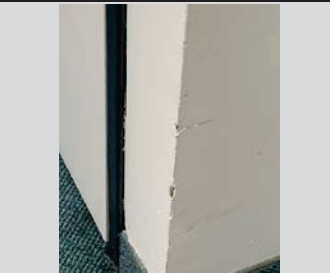
2
	SECOND FLOOR CORRIDOR	DRYWALL JOINT COMPOUND	DAMAGED DRYWALL	WALL EDGE	2 L. FT.	P1-1a (2010 Report)	1.5	CHRYSTILE	YES	POOR	A	NON-FRIABLE	THE DAMAGED DRYWALL WITH ASBESTOS-CONTAINING DRYWALL JOINT COMPOUND SHOULD BE REPAIRED FOLLOWING TYPE 1 ASBESTOS PROCEDURES, AS PRESCRIBED UNDER O. REG. 278/05.

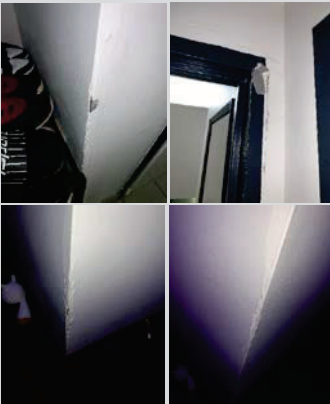
Unit#	Area	Material	Description	Location	Qty/Unit	Sample Number	%	Type	ACM (Yes, No, Suspect)	Condition	Accessibility	Friability	Comments	Photograph of Damaged ACM	Action Required
C1	ROOM C-1-H	DRYWALL JOINT COMPOUND	DAMAGED DRYWALL	WALL	5 SQ. FT.	P1-1a (2010 Report)	1.5	CHRYSTILE	YES	POOR	A	NON-FRIABLE	THE DAMAGED DRYWALL WITH ASBESTOS-CONTAINING DRYWALL JOINT COMPOUND SHOULD BE REPAIRED FOLLOWING TYPE 1 ASBESTOS PROCEDURES, AS PRESCRIBED UNDER O. REG. 278/05.

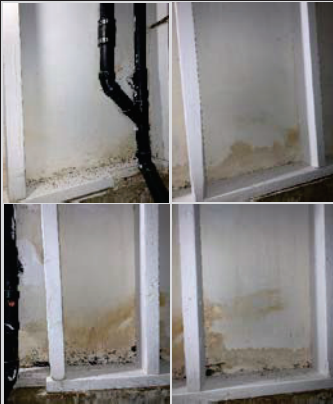
2
C3	THROUGHOUT	DRYWALL JOINT COMPOUND	WHITE DRYWALL JOINT COMPOUND	WALLS AND CEILINGS	3500 SQ. FT.	P1-1a (2010 Report)	1.5	CHRYSTILE	YES	GOOD	A	NON-FRIABLE			4
	THROUGHOUT	LIGHT FIXTURE	HEAT SHIELD PAPER	THROUGHOUT BUILDING	UNKNOWN	NOT SAMPLED	N/A	PRESUMED	PRESUMED	GOOD	D	FRIABLE	PRESUMED ACM, NOT PREVIOUSLY SAMPLED		4
	BASEMENT	DRYWALL JOINT COMPOUND	WATER DAMAGED AND MOULD IMPACTED DRYWALL	WALL	8 SQ. FT.	P1-1a (2010 Report)	1.5	CHRYSTILE	YES	POOR	A	NON-FRIABLE	THE DAMAGED DRYWALL WITH ASBESTOS-CONTAINING DRYWALL JOINT COMPOUND SHOULD BE REPAIRED FOLLOWING TYPE 1 ASBESTOS PROCEDURES, AS PRESCRIBED UNDER O. REG. 278/05.

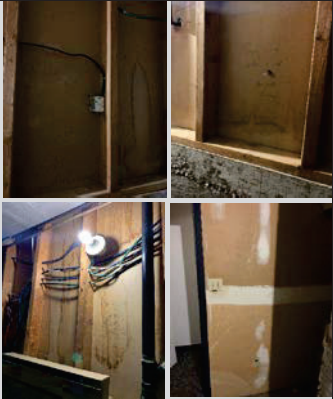
Unit#	Area	Material	Description	Location	Qty/Unit	Sample Number	%	Type	ACM (Yes, No, Suspect)	Condition	Accessibility	Friability	Comments	Photograph of Damaged ACM	Action Required
ELM HALL															
E1	THROUGHOUT	DRYWALL JOINT COMPOUND	WHITE DRYWALL JOINT COMPOUND	WALLS AND CEILINGS	3500 SQ. FT.	P1-1a (2010 Report)	1.5	CHRYSTILE	YES	GOOD	A	NON-FRIABLE			4
	BASEMENT	DRYWALL JOINT COMPOUND	WATER STAINED DRYWALL	WALL	10 SQ. FT.	P1-1a (2010 Report)	1.5	CHRYSTILE	YES	POOR	A	NON-FRIABLE	THE DAMAGED ASBESTOS-CONTAINING DRYWALL JOINT COMPOUND SHOULD BE REPAIRED FOLLOWING TYPE 2 ASBESTOS PROCEDURES, AS PRESCRIBED UNDER O. REG. 278/05 IN CONJUNCTION WITH EACC LEVEL 1 MOULD PROCEDURES.

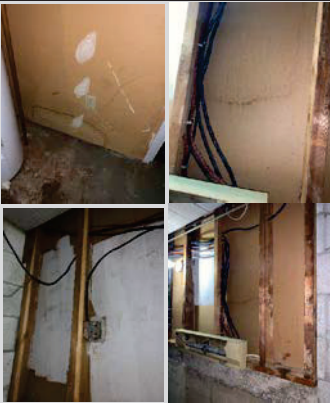
BASEMENT	DRYWALL JOINT COMPOUND	WATER STAINED	WALL	42 SQ. FT.	P1-1a (2010 Report)	1.5	CHRYSTILE	YES	POOR	A	NON-FRIABLE	THE DAMAGED DRYWALL WITH ASBESTOS-CONTAINING DRYWALL JOINT COMPOUND SHOULD BE REPAIRED FOLLOWING TYPE 2 ASBESTOS PROCEDURES, AS PRESCRIBED UNDER O. REG. 278/05 IN CONJUNCTION WITH EACC LEVEL 1 MOULD PROCEDURES.
