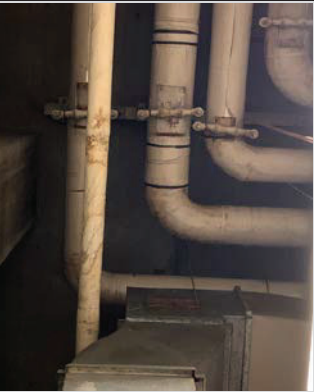
PARGING CEMENT INSULATION ON MECHANICAL PIPE FITTINGS	FITTINGS	PRESENT AT HIGH ELEVATION ADJACENT TO DUCTWORK	2	R-SA1	50-75	CHRYSTILE	FAIR	B	YES	FRIABLE	THE DAMAGED ASBESTOS-CONTAINING PARGING CEMENT ON FITTING SHOULD BE REPAIRED FOLLOWING TYPE 2 ASBESTOS PROCEDURES, AS PRESCRIBED UNDER O.REG. 278/05.

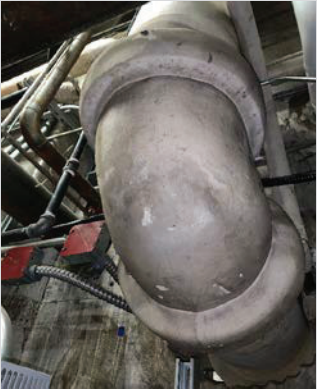
Room Number	Area #	Material	Description	Location	Qty/Unit	SA#	%	Type	Condition	Accessibility	ACM (Yes, No, Suspect)	Friability	Comments	Photographs	Action Required
S103B	MECHANICAL ROOM	PARGING CEMENT INSULATION ON MECHANICAL PIPE FITTINGS	FITTINGS	NEAR RED EXPANSION TANK	1	R-SA1	50-75	CHRYSTILE	FAIR	B	YES	FRIABLE	THE DAMAGED ASBESTOS-CONTAINING PARGING CEMENT ON FITTING SHOULD BE REPAIRED FOLLOWING TYPE 2 ASBESTOS PROCEDURES, AS PRESCRIBED UNDER O.REG. 278/05.

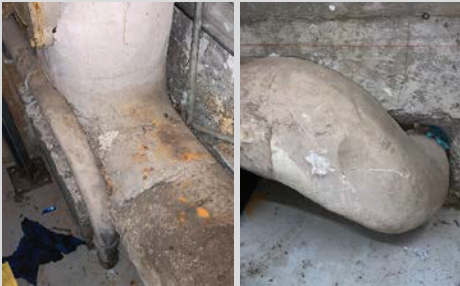
S103C	COMPRESSOR ROOM	PARGING CEMENT INSULATION ON MECHANICAL PIPE FITTINGS	DOMESTIC LINES	GENERAL ROOM/CEILING SPACE	4	R-SA1	50-75	CHRYSTILE	GOOD	C	YES	FRIABLE	VARIOUS FITTINGS REPAIRED IN 2017 (MAPLE PROJECT #16643). THREE FITTINGS REMOVED IN 2019 (MAPLE PROJECT #18098). TO VIEW PROJECT-SPECIFIC REPORT, SEE FACILITIES AND/OR HEALTH AND SAFETY.		4
		PARGING CEMENT INSULATION ON MECHANICAL PIPE FITTINGS	FITTINGS	GENERAL ROOM	3	R-SA1	50-75	CHRYSTILE	POOR	B	YES	FRIABLE	PRESENT ABOVE THE SINK WHERE PIPE ENTERS WALL. THE DAMAGED ASBESTOS-CONTAINING PARGING CEMENT ON FITTING SHOULD BE REPAIRED FOLLOWING TYPE 2 ASBESTOS PROCEDURES, AS PRESCRIBED UNDER O.REG. 278/05.

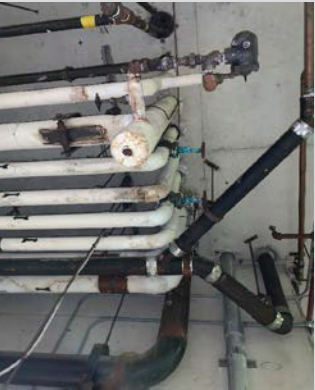
Room Number	Area #	Material	Description	Location	Qty/Unit	SA#	%	Type	Condition	Accessibility	ACM (Yes, No, Suspect)	Friability	Comments	Photographs	Action Required
S103F	MECHANICAL ROOM	PARGING CEMENT INSULATION ON MECHANICAL PIPE FITTINGS	FITTINGS	CEILING SPACE	75-100	R-SA1	50-75	CHRYSTILE	GOOD	B/C	YES	FRIABLE	SOME OF THE ASBESTOS-CONTAINING INSULATION ON PIPE FITTINGS MAY HAVE BEEN REPLACED WITH NEW, NON-ASBESTOS INSULATION. SELECT FITTINGS REMOVED IN JULY 2019 ACCORDING TO UTSC NOTICE OF PROJECTS.		4
		PARGING CEMENT INSULATION ON MECHANICAL PIPE FITTINGS	FITTINGS	ACROSS FROM LOCATION 103J AT THE CONCRETE SLAB	3	R-SA1	35-50	CHRYSTILE	POOR	B/C	YES	FRIABLE	MOULD-IMPACTED FITTINGS. THE DAMAGED ASBESTOS-CONTAINING PARGING CEMENT INSULATION SHOULD BE REMOVED FOLLOWING TYPE 2 GLOVE BAG PROCEDURES, AS PRESCRIBED UNDER O.REG. 278/05.

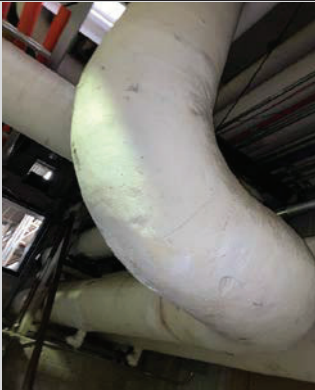
TAR ON STRAIGHT RUN	CHILLED WATER RETURN	GENERAL ROOM/CEILING SPACE	20 LN. FT.	R-SA7	15	CHRYSTILE	GOOD	B/C	YES	NON-FRIABLE			4
		PARGING CEMENT INSULATION ON MECHANICAL PIPE FITTINGS	CHILLED WATER RETURN	GENERAL ROOM/CEILING SPACE	8	R-SA2	50-75	CHRYSTILE	GOOD	B/C	YES	FRIABLE			4
		PARGING CEMENT INSULATION ON MECHANICAL PIPE FITTINGS	FITTINGS	GENERAL ROOM - NEAR DOOR TO SW103R	2	R-SA2	50-75	CHRYSTILE	POOR	B/C	YES	FRIABLE	THE DAMAGED ASBESTOS-CONTAINING PARGING CEMENT ON FITTING SHOULD BE REPAIRED FOLLOWING TYPE 2 ASBESTOS PROCEDURES, AS PRESCRIBED UNDER O.REG. 278/05.

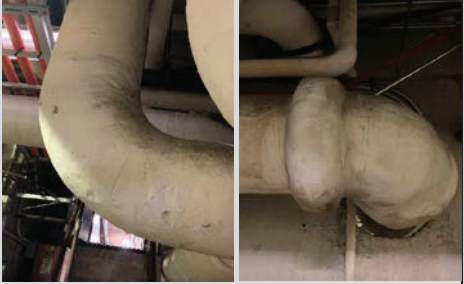
2
		PARGING CEMENT INSULATION ON MECHANICAL PIPE FITTINGS	FITTINGS	GENERAL ROOM - NEAR DOOR TO SW103S	2	R-SA2	50-75	CHRYSTILE	POOR	B/C	YES	FRIABLE	THE DAMAGED ASBESTOS-CONTAINING PARGING CEMENT ON FITTING SHOULD BE REPAIRED FOLLOWING TYPE 2 ASBESTOS PROCEDURES, AS PRESCRIBED UNDER O.REG. 278/05.

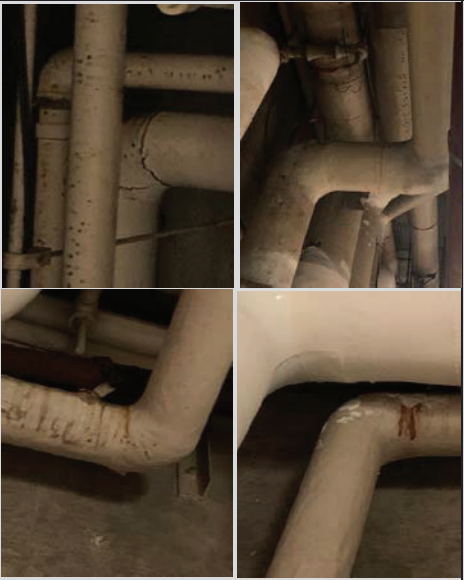
PARGING CEMENT INSULATION ON MECHANICAL PIPE FITTINGS	HOT WATER RECIRCULATE	GENERAL ROOM/CEILING SPACE	24	R-SA1	50-75	CHRYSTILE	GOOD	B/C	YES	FRIABLE			4
		PARGING CEMENT INSULATION ON MECHANICAL PIPE FITTINGS	FITTINGS	GENERAL ROOM - NEAR ENTRANCE TO ROOM S103I	5	R-SA1	50-75	CHRYSTILE	POOR	B/C	YES	FRIABLE	THE DAMAGED ASBESTOS-CONTAINING PARGING CEMENT FITTING SHOULD BE REPAIRED FOLLOWING TYPE 2 ASBESTOS PROCEDURES, AS PRESCRIBED UNDER O.REG. 278/05.

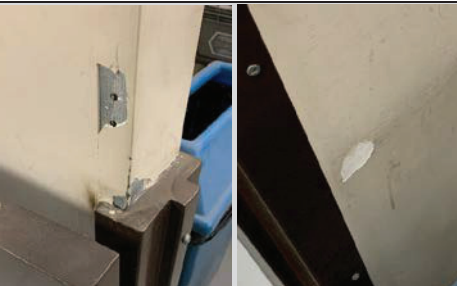
S112	CENTRAL STORES	DRYWALL	DRYWALL JOINT COMPOUND	WALL	250 SQ. FT.	R-SA1-A-07	0.75	CHRYSTILE	GOOD	A	YES	NON-FRIABLE			4
		DRYWALL	DRYWALL JOINT COMPOUND	WALL	1 SQ. FT	R-SA1-A-07 & 18419 S03A & S03B	0.75	CHRYSTILE	FAIR	A	YES	NON-FRIABLE	DAMAGE TO EDGING. THE DAMAGED ASBESTOS-CONTAINING DRYWALL FINISH SHOULD BE REPAIRED FOLLOWING TYPE 1 ASBESTOS PROCEDURES, AS PRESCRIBED UNDER O.REG. 278/05.

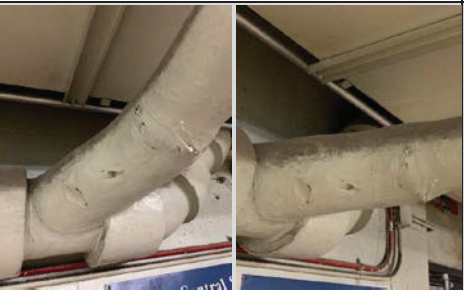
Room Number	Area #	Material	Description	Location	Qty/Unit	SA#	%	Type	Condition	Accessibility	ACM (Yes, No, Suspect)	Friability	Comments	Photographs	Action Required
S114A	WALKWAY	PARGING CEMENT INSULATION ON MECHANICAL PIPE FITTINGS	FITTINGS	GENERAL ROOM	5	R-SA1	50-75	CHRYSTILE	GOOD	B	YES	FRIABLE			4
		PARGING CEMENT INSULATION ON MECHANICAL PIPE FITTINGS	FITTINGS	GENERAL ROOM	2	R-SA1	50-75	CHRYSTILE	POOR	B	YES	FRIABLE	THE DAMAGED ASBESTOS-CONTAINING PARGING CEMENT INSULATION SHOULD BE REPAIRED FOLLOWING TYPE 2 ASBESTOS PROCEDURES, AS PRESCRIBED UNDER O.REG. 278/05.

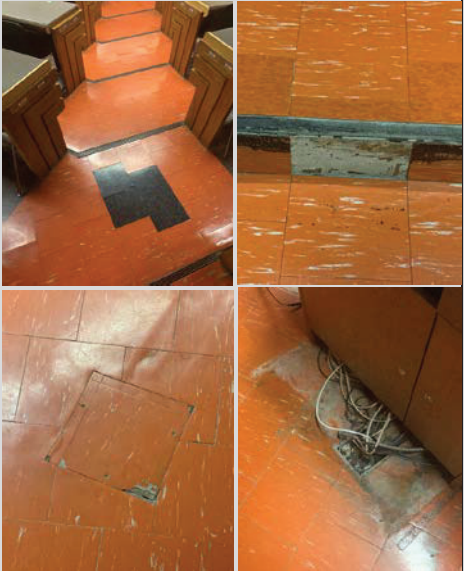
Room Number	Area #	Material	Description	Location	Qty/Unit	SA#	%	Type	Condition	Accessibility	ACM (Yes, No, Suspect)	Friability	Comments	Photographs	Action Required
S128	LECTURE HALL	NEW VINYL SHEET FLOORING									NO		ACM TILES AND MASTIC MAY BE PRESENT BELOW		N/A
		VINYL FLOOR TILES	9x9 BROWN FLOOR TILE	FLOOR	500 SQ. FT.	R-SA86 & R-SA112-A-06	<2	CHRYSTILE	GOOD	A	YES	NON-FRIABLE	ACM DETECTED IN BOTH TILE AND MASTIC.		4
		VINYL FLOOR TILES	9x9 ORANGE FLOOR TILE	FLOOR - SPORADIC DAMAGE	8 SQ. FT	R-R-SA113-B-06 & R-SA88	<5	CHRYSTILE	POOR	A	YES	NON-FRIABLE	THE DAMAGED ASBESTOS-CONTAINING VINYL FLOOR TILES AND MASTIC SHOULD BE REMOVED FOLLOWING TYPE 1 OR 2 ASBESTOS PROCEDURES, AS PRESCRIBED UNDER O.REG. 278/05.

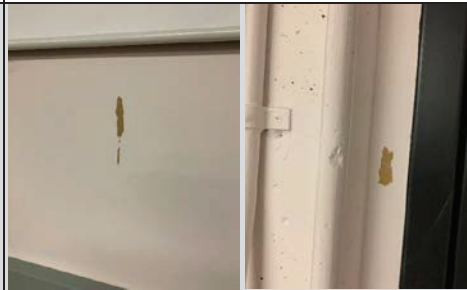
DRYWALL	DRYWALL JOINT COMPOUND	WALL	142 SQ. FT.	25622-022-25A-C	1	CHRYOTILE	GOOD	A	YES	NON-FRIABLE			4
		DRYWALL	DRYWALL JOINT COMPOUND	WALL	1 SQ. FT.	25622-022-25A-C	1	CHRYOTILE	FAIR	A	YES	NON-FRIABLE	REPAIR FOLLOWING TYPE 1 ASBESTOS PROCEDURES, AS PRESCRIBED UNDER O.REG. 278/05.

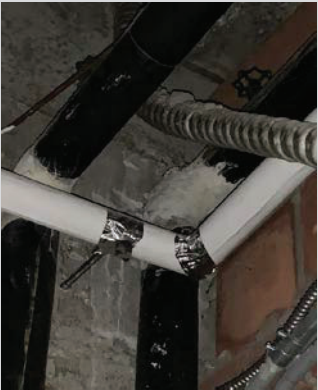
2
		PARGING CEMENT INSULATION ON MECHANICAL PIPE FITTINGS	FITTINGS	IN THE BACK LEFT CORNER AT THE METAL GRATE (FLOOR LEVEL) AT LADDER. DEBRIS ALSO PRESENT IN THE WALL CAVITY	1	R-SA1	50-75	CHRYSTILE	FAIR	C	YES	FRIABLE	THE DAMAGED ASBESTOS-CONTAINING PARGING CEMENT ON FITTING SHOULD BE REPAIRED FOLLOWING TYPE 2 ASBESTOS PROCEDURES, AS PRESCRIBED UNDER O.REG. 278/05.

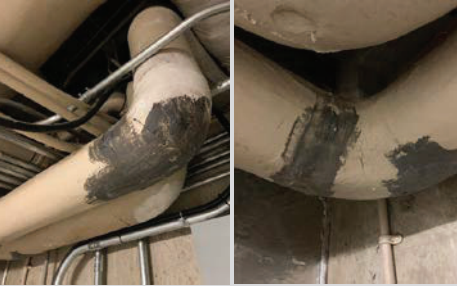
2
		PARGING CEMENT INSULATION ON MECHANICAL PIPE FITTINGS	FITTINGS	ON WALL COLUMN, NEAR DOOR TO SW612	1	R-SA60	50-75	CHRYSTILE	POOR	B	YES	FRIABLE	THE DAMAGED ASBESTOS-CONTAINING PARGING CEMENT INSULATION SHOULD BE REPAIRED FOLLOWING TYPE 2 ASBESTOS PROCEDURES, AS PRESCRIBED UNDER O.REG. 278/05.

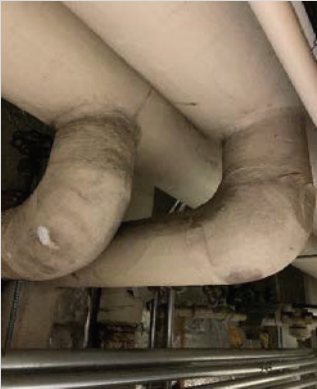
2
		PARGING CEMENT INSULATION ON MECHANICAL PIPE FITTINGS	FITTINGS	NEAR DOOR TO SW612A	1	R-SA60	50-75	CHRYSTILE	POOR	B	YES	FRIABLE	THE DAMAGED ASBESTOS-CONTAINING PARGING CEMENT INSULATION SHOULD BE REPAIRED FOLLOWING TYPE 2 ASBESTOS PROCEDURES, AS PRESCRIBED UNDER O.REG. 278/05.

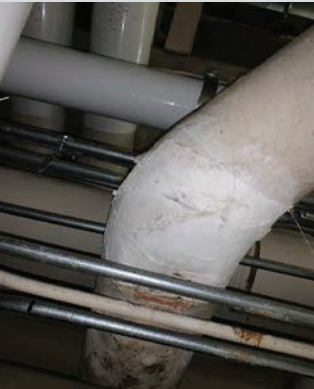
2
		PARGING CEMENT INSULATION ON MECHANICAL PIPE FITTINGS	FITTINGS	NEAR AC #10	1	R-SA60	50-75	CHRYSTILE	POOR	B	YES	FRIABLE	THE DAMAGED ASBESTOS-CONTAINING PARGING CEMENT INSULATION SHOULD BE REPAIRED FOLLOWING TYPE 2 ASBESTOS PROCEDURES, AS PRESCRIBED UNDER O.REG. 278/05.

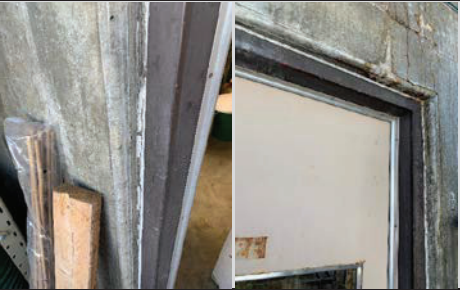
2
		PAINTED TEXTURE COAT OVER PLASTER	PAINTED TEXTURE COAT OVER PLASTER	WALL - ABOVE DOOR		SA 01 (A-G)	ND	ND			NO		SAMPLED FROM VARIOUS LOCATIONS THROUGHOUT THE SCIENCE BUILDING DURING THE 2016 REASSESSMENT.		N/A
		TRANSITE™ ASBESTOS CEMENT	WALL	WALL	50	R-SA22	15-25	CROCIDOLITE	POOR	A	YES	NON-FRIABLE	DURING 2022 REASSESSMENT, TRANSITE ASBESTOS-CEMENT WAS OBSERVED ON THE PERIMETER WALLS OF THE GREENHOUSE. REMOVE FOLLOWING TYPE 1 ASBESTOS PROCEDURES AS PRESCRIBED UNDER O.REG. 278/05
