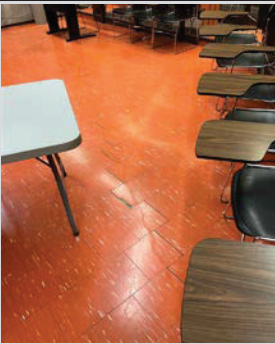
2'x4' ACOUSTIC TILES	UNKNOWN	CEILING		R-SA45 & R-SA-123-(A-B)-06		ND			NO				N/A
		NEW LAY-IN CEILING TILES									NO		MATERIAL NOT SUSPECTED TO CONTAIN ASBESTOS		N/A
S143	LECTURE HALL	VINYL FLOOR TILES	12x12 BROWN FLOOR TILE	FLOOR	1008 SQ. FT.	R-SA113-B-06 & R-SA88	<5	CHRYSTILE	GOOD	A	YES	NON-FRIABLE	ACM DETECTED IN BOTH TILE AND MASTIC		4
		VINYL FLOOR TILES	9x9 ORANGE FLOOR TILE	FLOOR	100 SQ. FT.	R-SA86 & R-SA112-A-06	<2	CHRYSTILE	GOOD	A	YES	NON-FRIABLE	ACM DETECTED IN BOTH TILE AND MASTIC		4
		VINYL FLOOR TILES	9x9 ORANGE FLOOR TILE	FLOOR - SPORADIC DAMAGE	10 SQ. FT.	R-SA86 & R-SA112-A-06	<2	CHRYSTILE	FAIR	A	YES	NON-FRIABLE	ACM DETECTED IN BOTH TILE AND MASTIC. THE DAMAGED ASBESTOS-CONTAINING VINYL FLOOR TILES AND MASTIC SHOULD BE REMOVED FOLLOWING TYPE 1 OR 2 ASBESTOS PROCEDURES, AS PRESCRIBED UNDER O.REG. 278/05.

2
		PLASTER	WHITE & GREY PLASTER	CEILING		25891-4A, 25891-4B, 25891-4C		ND			ND		SAMPLED BY OHE (Project #25891) IN 2020.		N/A

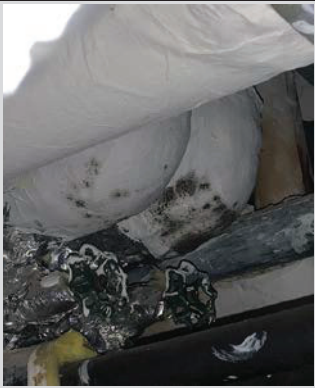
Room Number	Area #	Material	Description	Location	Qty/Unit	SA#	%	Type	Condition	Accessibility	ACM (Yes, No, Suspect)	Friability	Comments	Photographs	Action Required
S149V	VESTIBULE	PARGING CEMENT INSULATION ON MECHANICAL PIPE FITTINGS	FITTINGS	ABOVE CEILING TILES	2	R-SA1	50-75	CHRYSOTILE	POOR	C	YES	FRIABLE	PRESENT IN CEILING SPACE. THE MOULD IMPACTED ASBESTOS-CONTAINING PARGING CEMENT INSULATION SHOULD BE REMOVED FOLLOWING TYPE 2 GLOVE BAG PROCEDURES, AS PRESCRIBED UNDER O.REG. 278/05.

2
		2'x4' ACOUSTIC TILES	UNKNOWN	CEILING		R-SA45 & R-SA-123-(A-B)-06		ND			NO				N/A
S150	WAITING AREA	DRYWALL	DRYWALL JOINT COMPOUND	WALL	150 SQ. FT.	R-SA52	0.25	CHRYSOTILE	GOOD	A	SUSPECT	NON-FRIABLE	ADDITIONAL SAMPLING IS RECOMMENDED.		4
		NEW LAY-IN CEILING TILES									NO		MATERIAL NOT SUSPECTED TO CONTAIN ASBESTOS		N/A
		NEW VINYL SHEET FLOORING									NO		MASTIC REMOVED IN 2018 (MAPLE PROJECT 16687)		N/A

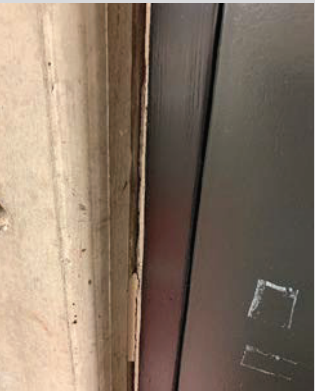
S150A	PSYCHOLOGY	NEW VINYL SHEET FLOORING		FLOOR							NO				N/A
		CAULKING	GREY CAULKING	WALL	4 L. FT.	25622-022-26A-C	1	CHRYSOTILE	POOR	a	YES	NON-FRIABLE	SAMPLED BY OHE IN 2022 (OHE PROJECT 25622-022). REMOVE DAMAGED MATERIALS FOLLOWING TYPE 1 ASBESTOS PROCEDURE, AS PRESCRIBED UNDER O.REG. 278/05.

2
		VINYL FLOOR TILES	9x9 BROWN FLOOR TILE	FLOOR	302 SQ. FT.	R-SA86 & R-SA112-A-06	<2	CHRYSOTILE	GOOD	A	YES	NON-FRIABLE	NOT FOUND DURING THE 2021 REASSESSMENT (COULD BE BELOW NEW VINYL SHEET FLOORING). ACM DETECTED IN BOTH TILE AND MASTIC		4
		DRYWALL	DRYWALL JOINT COMPOUND	WALL	180 SQ. FT.	R-SA52	0.25	CHRYSOTILE	GOOD	A	SUSPECT	NON-FRIABLE	ADDITIONAL SAMPLING IS RECOMMENDED.		4
S150B	LAB	DRYWALL	DRYWALL JOINT COMPOUND	WALL AND CEILING	120 SQ. FT.	R-SA52	0.25	CHRYSOTILE	GOOD	A	SUSPECT	NON-FRIABLE	ADDITIONAL SAMPLING IS RECOMMENDED. NO ACCESS ABOVE CEILING		4
S150C	LAB	DRYWALL	DRYWALL JOINT COMPOUND	WALL AND CEILING	50 SQ. FT.	R-SA52	0.25	CHRYSOTILE	GOOD	A	SUSPECT	NON-FRIABLE	ADDITIONAL SAMPLING IS RECOMMENDED. NO ACCESS ABOVE CEILING		4

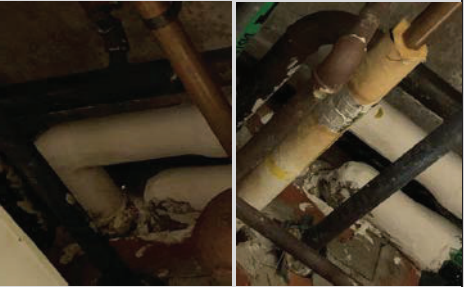
Room Number	Area #	Material	Description	Location	Qty/Unit	SA#	%	Type	Condition	Accessibility	ACM (Yes, No, Suspect)	Friability	Comments	Photographs	Action Required
S152B	MECHANICAL ROOM	PARGING CEMENT INSULATION ON MECHANICAL PIPE FITTINGS	FITTINGS	GENERAL ROOM	7	R-SA1	50-75	CHRYSTILE	GOOD	C	YES	FRIABLE			4
		PARGING CEMENT INSULATION ON MECHANICAL PIPE FITTINGS	FITTINGS	DOMESTIC WATER LINE ABOVE CEILING	7	R-SA1	50-75	CHRYSTILE	FAIR	C	YES	FRIABLE	UNJACKETED INSULATION ON DOMESTIC WATER LINE ABOVE CEILING. THE DAMAGED ASBESTOS-CONTAINING PARGING CEMENT INSULATION SHOULD BE REPAIRED FOLLOWING TYPE 2 ASBESTOS PROCEDURES, AS PRESCRIBED UNDER O.REG. 278/05.

2
S152C	ROOM	NO SUSPECT ACM OBSERVED									NO				N/A
S152V	VESTIBULE	NO SUSPECT ACM OBSERVED									NO		ALL ACM REMOVED IN 2017 (MAPLE PROJECT #18574). TO VIEW PROJECT-SPECIFIC REPORT, SEE FACILITIES AND/OR HEALTH AND SAFETY.		N/A
S153	LAB	DRYWALL	DRYWALL JOINT COMPOUND	WALL	600 SQ. FT.	R-SA52	0.25	CHRYSTILE	GOOD	A	SUSPECT	NON-FRIABLE	ADDITIONAL SAMPLING IS RECOMMENDED.		4

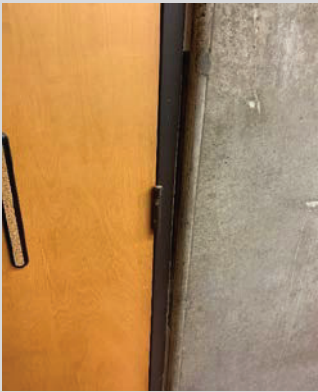
Room Number	Area #	Material	Description	Location	Qty/Unit	SA#	%	Type	Condition	Accessibility	ACM (Yes, No, Suspect)	Friability	Comments	Photographs	Action Required
S155	HALLWAY	PARGING CEMENT INSULATION ON MECHANICAL PIPE FITTINGS	FITTINGS	CEILING SPACE	16	R-SA1	50-75	CHRYSTILE	GOOD	C	YES	FRIABLE	REPAIRED IN 2014		4
		CAULKING	BEIGE CAULKING	DOOR	3 L.FT.	CLK01A-C	0.5	CHRYSTILE	GOOD	C	YES	NON-FRIABLE	SAMPLED BY GOLDR IN 2022 (GOLDR PROJECT 22525284). REMOVE ASBESTOS-CONTAINING CAULKING FOLLOWING TYPE 1 PROCEDURES PRESCRIBED IN O.REG 278/05.

2
		CAULKING	BEIGE CAULKING	DOOR	17 L.FT.	CLK01A-C	0.5	CHRYSTILE	GOOD	C	YES	NON-FRIABLE	SAMPLED BY GOLDR IN 2022 (GOLDR PROJECT 22525284)		4
		PLASTER	PLASTER	ABOVE DOOR		PLA01C	ND	ND			NO		SAMPLED BY GOLDR IN 2022 (PROJECT 22521196-1000)		N/A
		MASTIC	BEIGE MASTIC	DUCT		DM01A-C		ND			NO		SAMPLED BY GOLDR IN 2022 (GOLDR PROJECT 22525284)		N/A
		CEILING TILES	2'X4' WITH PINHOLE PATTERN	CEILING		ACT01A-C		ND			NO		SAMPLED BY GOLDR IN 2022 (GOLDR PROJECT 22525284)		N/A

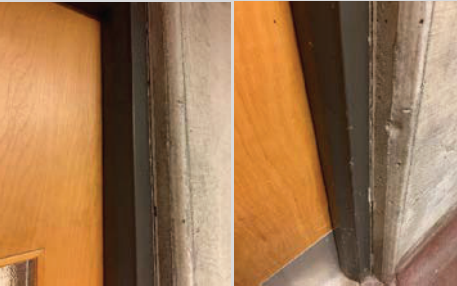
S162A	LAB	NO SUSPECT ACM OBSERVED									NO		ALL ACM REMOVED IN NOVEMBER, 2017 (MAPLE PROJECT #16553). TO VIEW PROJECT-SPECIFIC REPORT, SEE FACILITIES AND/OR HEALTH AND SAFETY.		N/A
S162B	LAB	NO SUSPECT ACM OBSERVED									NO		ALL ACM REMOVED IN NOVEMBER, 2017 (MAPLE PROJECT #16553). TO VIEW PROJECT-SPECIFIC REPORT, SEE FACILITIES AND/OR HEALTH AND SAFETY.		N/A
S164	LAB	ACOUSTIC TILES	UNKNOWN	CEILING		R-SA3-A-07		ND			NO		ACM PIPE FITTINGS SUSPECTED PRESENT ABOVE CEILING TILES - LIMITED VIEW.		N/A
		NEW LAY-IN CEILING TILES									NO		MATERIAL NOT SUSPECTED TO CONTAIN ASBESTOS		N/A
		CAULKING	DOOR CAULKING	DELAMINATED AT DOOR	15 L. FT.	SA134	>4	CHRYSTILE	POOR	A	YES	NON-FRIABLE	IT IS RECOMMENDED THAT ALL TAN CAULKING BE CONSIDERED ASBESTOS CONTAINING THROUGHOUT THE S-WING. THE DAMAGED ASBESTOS-CONTAINING CAULKING SHOULD BE REMOVED FOLLOWING TYPE 1 ASBESTOS PROCEDURES, AS PRESCRIBED UNDER O.REG. 278/05.

2

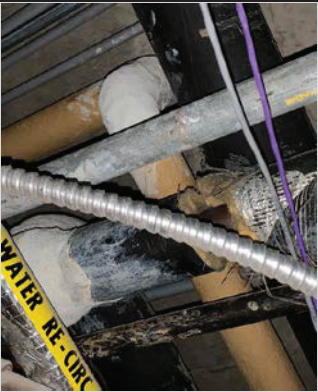
Room Number	Area #	Material	Description	Location	Qty/Unit	SA#	%	Type	Condition	Accessibility	ACM (Yes, No, Suspect)	Friability	Comments	Photographs	Action Required
S164A	LAB	NO SUSPECT ACM OBSERVED									NO				N/A
S164V	VESTIBULE	PARGING CEMENT INSULATION ON MECHANICAL PIPE FITTINGS	FITTINGS	ABOVE CEILING TILES	1	R-SA1	50-75	CHRYSTILE	POOR	C	YES	FRIABLE	PRESENT IN CEILING SPACE. THE DAMAGED ASBESTOS-CONTAINING PARGING CEMENT INSULATION SHOULD BE REMOVED FOLLOWING TYPE 2 GLOVE BAG PROCEDURES, AS PRESCRIBED UNDER O.REG. 278/05.

2
		2'x4' ACOUSTIC TILES	PINHOLES	CEILING	60 SQ. FT.	SA56		ND			NO				N/A
		PAINTED TEXTURE COAT OVER PLASTER	PAINTED TEXTURE COAT OVER PLASTER	WALL - ABOVE DOORS		SA 01 (A-G)	ND	ND			NO		SAMPLED FROM VARIOUS LOCATIONS THROUGHOUT THE SCIENCE BUILDING DURING THE 2016 REASSESSMENT.		N/A
S165	LAB	NO SUSPECT ACM OBSERVED									NO		ALL ACM REMOVED IN NOVEMBER, 2017 (MAPLE PROJECT #16687). TO VIEW PROJECT-SPECIFIC REPORT, SEE FACILITIES AND/OR HEALTH AND SAFETY.		N/A

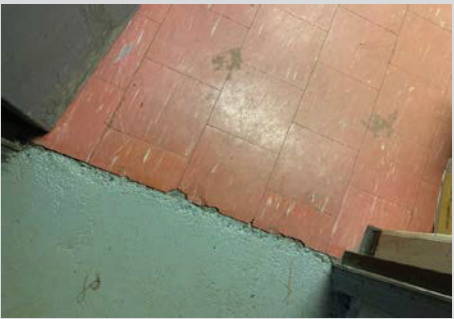
Room Number	Area #	Material	Description	Location	Qty/Unit	SA#	%	Type	Condition	Accessibility	ACM (Yes, No, Suspect)	Friability	Comments	Photographs	Action Required
S200B	STORAGE	VINYL FLOOR TILES	9x9 RED FLOOR TILES	FLOOR	200 SQ. FT.	R-SA18	5	CHRYSTILE	GOOD	A	YES	NON-FRIABLE			4
		VINYL FLOOR TILES	9x9 RED FLOOR TILES	FLOOR AT DOOR THRESHOLD	5 SQ. FT	R-SA18	5	CHRYSTILE	POOR	A	YES	NON-FRIABLE	DAMAGED AT DOOR THRESHOLD. THE ASBESTOS-CONTAINING VINYL FLOOR TILES AND MASTIC SHOULD BE REMOVED FOLLOWING TYPE 1 OR 2 ASBESTOS PROCEDURES, AS PRESCRIBED UNDER O.REG. 278/05.

2
S200C	STORAGE	DRYWALL	DRYWALL JOINT COMPOUND	WALL	150 SQ. FT.	R-SA52	0.25	CHRYSTILE	GOOD	A	SUSPECT	NON-FRIABLE	ADDITIONAL SAMPLING IS RECOMMENDED.		4
S200D	SPRINKLER ROOM	PARGING CEMENT INSULATION ON MECHANICAL PIPE FITTINGS	FITTINGS	GENERAL ROOM AND CEILING	8	R-SA1	50-75	CHRYSTILE	GOOD	B/C	YES	FRIABLE			4
S200E	ELEVATOR	NO SUSPECT ACM OBSERVED									NO				N/A

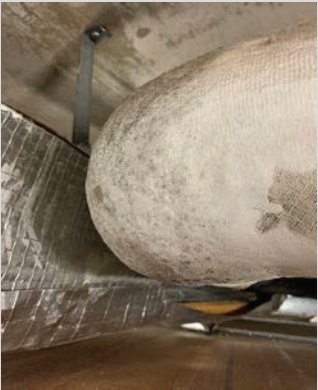
Room Number	Area #	Material	Description	Location	Qty/Unit	SA#	%	Type	Condition	Accessibility	ACM (Yes, No, Suspect)	Friability	Comments	Photographs	Action Required
S205K	CORRIDOR	DRYWALL	DRYWALL JOINT COMPOUND	CEILING	UNKNOWN	27531-1A-C	1	CHRYSTILE	GOOD	A	YES	NON-FRIABLE	SAMPLED BY OHE IN 2022 (OHE PROJECT 27531). TO VIEW PROJECT-SPECIFIC REPORT, SEE FACILITIES AND/OR HEALTH AND SAFETY.		4
		SHEETING	BLACK/GREEN RUBBERY MATERIAL	CEILING		27531-2A-C		ND			NO		SAMPLED BY OHE IN 2022 (OHE PROJECT 27531). TO VIEW PROJECT-SPECIFIC REPORT, SEE FACILITIES AND/OR HEALTH AND SAFETY.		N/A
		PARGING CEMENT INSULATION ON MECHANICAL PIPE FITTINGS	FITTINGS	ABOVE CEILING TILES	2	R-SA1	50-75	CHRYSTILE	POOR	C	YES	FRIABLE	MOULD IMPACTED FITTINGS SHOULD BE REMOVED FOLLOWING TYPE 2 GLOVE BAG PROCEDURES AS PRESCRIBED UNDER O.REG. 278/05.

2
S205S	STAIRWELL	PLASTER	SMOOTH PLASTER	CEILING	UNKNOWN	16365-S02A-C	<0.5	TREMOLITE	GOOD	A	NO	FRIABLE	LOCATED OUTSIDE THE STAIRWELL AT LIGHT FIXTURE. SAMPLED BY MAPLE IN 2017. TO VIEW PROJECT-SPECIFIC REPORT, SEE FACILITIES AND/OR HEALTH AND SAFETY.		N/A

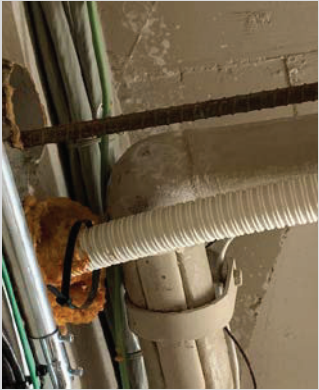
Room Number	Area #	Material	Description	Location	Qty/Unit	SA#	%	Type	Condition	Accessibility	ACM (Yes, No, Suspect)	Friability	Comments	Photographs	Action Required
S208A	BELL CANADA ROOM	GREY VINYL SHEET FLOORING	LIGHT BROWN MOSAIC- NEW	FLOOR		R-SA-012 & R-SA-108(A-C)-06		ND			NO				N/A
		PARGING CEMENT INSULATION ON MECHANICAL PIPE FITTINGS	FITTINGS	ABOVE CEILING TILES	1	R-SA1	50-75	CHRYSTILE	POOR	C	YES	FRIABLE	PRESENT IN CEILING SPACE. THE DAMAGED ASBESTOS-CONTAINING PARGING CEMENT INSULATION SHOULD BE REMOVED FOLLOWING TYPE 2 GLOVE BAG PROCEDURES, AS PRESCRIBED UNDER O.REG. 278/05.

2
		PARGING CEMENT INSULATION ON MECHANICAL PIPE FITTINGS	FITTINGS	CEILING SPACE	2	R-SA1	50-75	CHRYSTILE	GOOD	C	YES	FRIABLE	SELECT FITTINGS REMOVED IN OCTOBER 2019 ACCORDING TO UTSC NOTICE OF PROJECT.		4
		ELECTRICAL WIRES AND CABLE SHEATHING	ELECTRICAL WIRES AND CABLE SHEATHING	GENERAL ROOM	UNKNOWN				GOOD	B	SUSPECT		ALL EQUIPMENT WAS LIVE- NO ACCESS- PRESUMED ACM UNTIL PROVEN OTHERWISE		4

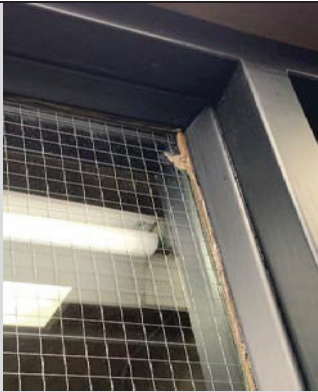
Room Number	Area #	Material	Description	Location	Qty/Unit	SA#	%	Type	Condition	Accessibility	ACM (Yes, No, Suspect)	Friability	Comments	Photographs	Action Required
S210K	CORRIDOR	2'x4' ACOUSTIC TILES	LENGTH-WISE FISSURE	CEILING	730 SQ. FT.	R-SA11 & R-SA120-(A-F)-06		ND			NO				N/A
		PARGING CEMENT INSULATION ON MECHANICAL PIPE FITTINGS	FITTINGS	ABOVE CEILING TILES	25-35	R-SA1	50-75	CHRYSTILE	GOOD	C	YES	FRIABLE	REPAIRED IN 2014. FIFTEEN FITTINGS REMOVED IN 2019 (MAPLE PROJECT #18314). TO VIEW PROJECT-SPECIFIC REPORT, SEE FACILITIES AND/OR HEALTH AND SAFETY.		4
S210S	STAIRWELL	PARGING CEMENT INSULATION ON MECHANICAL PIPE FITTINGS	FITTINGS	CEILING SPACE	2	R-SA1	50-75	CHRYSTILE	GOOD	C	YES	FRIABLE			4
		GREY CAULKING AROUND DOOR GLASS PANELS	DOOR CAULKING	DOOR TO STAIRWELL	14 L. FT.	25622-022-1A-C	3	CHRYSTILE	GOOD	A	YES	NON-FRIABLE			4
		GREY CAULKING AROUND DOOR GLASS PANELS	DOOR CAULKING	DOOR TO STAIRWELL	1 L. FT.	25622-022-1A-C	3	CHRYSTILE	FAIR	A	YES	NON-FRIABLE	REMOVE DAMAGED MATERIALS FOLLOWING TYPE 1 ASBESTOS PROCEDURE, AS PRESCRIBED UNDER O.REG. 278/05. SAMPLED BY OHE (PROJECT #25622-022) IN 2022

2

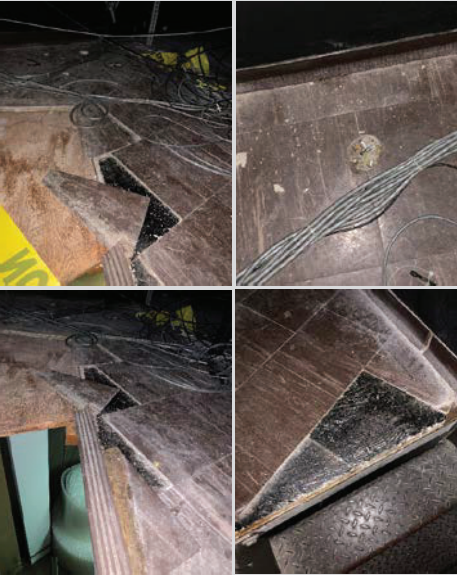
Room Number	Area #	Material	Description	Location	Qty/Unit	SA#	%	Type	Condition	Accessibility	ACM (Yes, No, Suspect)	Friability	Comments	Photographs	Action Required
S218A	LECTURE HALL - STORAGE	VINYL FLOOR TILES	9x9 BROWN FLOOR TILE	FLOOR	800 SQ. FT.	R-SA86 & R-SA112-A-06	<2	CHRYSTILE	GOOD	A	YES	NON-FRIABLE	ACM DETECTED IN BOTH TILE AND MASTIC		4
		PARGING CEMENT INSULATION ON MECHANICAL PIPE FITTINGS	FITTINGS	GENERAL ROOM AND CEILING	~15	R-SA1	50-75	CHRYSTILE	GOOD	A/C	YES	FRIABLE			4
		VINYL FLOOR TILES	9x9 BROWN FLOOR TILE	FLOOR - SPORADIC DAMAGE	8 SQ. FT.	R-SA86 & R-SA112-A-06	<2	CHRYSTILE	POOR	A	YES	NON-FRIABLE	ACM DETECTED IN BOTH TILE AND MASTIC. THE DAMAGED ASBESTOS-CONTAINING VINYL FLOOR TILES AND MASTIC SHOULD BE REMOVED FOLLOWING TYPE 1 OR 2 ASBESTOS PROCEDURES, AS PRESCRIBED UNDER O.REG. 278/05.

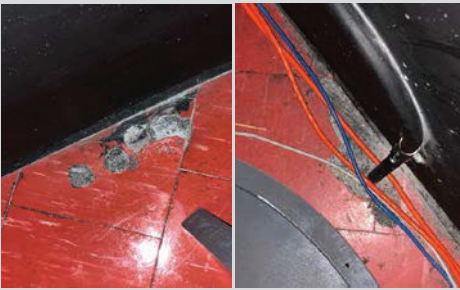
Room Number	Area #	Material	Description	Location	Qty/Unit	SA#	%	Type	Condition	Accessibility	ACM (Yes, No, Suspect)	Friability	Comments	Photographs	Action Required
S220	OFFICE	VINYL FLOOR TILES	9x9 RED FLOOR TILES	FLOOR	400 SQ. FT.	R-SA18	5	CHRYSTILE	GOOD	A	YES	NON-FRIABLE	ACM DETECTED IN BOTH TILE AND MASTIC		4
		VINYL FLOOR TILES	9x9 RED FLOOR TILES	FLOOR - SPORADIC DAMAGE	4 SQ. FT	R-SA18	5	CHRYSTILE	POOR	A	YES	NON-FRIABLE	ACM DETECTED IN BOTH TILE AND MASTIC. THE DAMAGED ASBESTOS-CONTAINING VINYL FLOOR TILES AND MASTIC SHOULD BE REMOVED FOLLOWING TYPE 1 OR 2 ASBESTOS PROCEDURES, AS PRESCRIBED UNDER O.REG. 278/05.

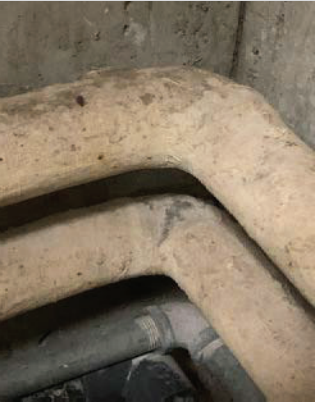
ASBESTOS WOVEN MATERIAL	ASBESTOS WOVEN MATERIAL	OVENS	20 SQ. FT				GOOD	A	SUSPECT	FRIABLE	NO SAMPLE - PRESUMED ACM		4
		PARGING CEMENT INSULATION ON MECHANICAL PIPE FITTINGS	DOMESTIC LINES	GENERAL ROOM / CEILING SPACE	25-30	R-SA1	50-75	CHRYSTILE	GOOD	A	YES	FRIABLE	INSULATION ON THE CONDENSATE TANK WAS REMOVED IN 2022 (CURMANN PROJECT 22-0145)		4
		PARGING CEMENT INSULATION ON MECHANICAL PIPE FITTINGS	PARGING CEMENT	GENERAL ROOM / CEILING SPACE	2	R-SA1	50-75	CHRYSTILE	FAIR	A	YES	FRIABLE	MOULD IMPACTED FITTINGS SHOULD BE REMOVED FOLLOWING TYPE 2 GLOVE BAG PROCEDURES AS PRESCRIBED UNDER O.REG. 278/05.

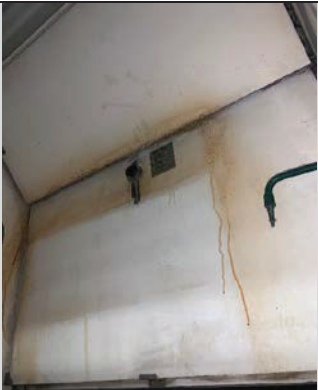
Room Number	Area #	Material	Description	Location	Qty/Unit	SA#	%	Type	Condition	Accessibility	ACM (Yes, No, Suspect)	Friability	Comments	Photographs	Action Required
S237	BIOLOGICAL SCIENCES TEACHING PREP	TRANSITE™ ASBESTOS-CEMENT	COUNTER AND FUME HOOD	GENERAL ROOM	200 SQ. FT	R-SA22	15-25	CROCIDOLITE	GOOD	A	YES	NON-FRIABLE			4
		TRANSITE™ ASBESTOS CEMENT	COUNTER AND FUME HOOD	GENERAL ROOM	10 SQ. FT	R-SA22	15-25	CROCIDOLITE	POOR	A	YES	NON-FRIABLE	MOULD IMPACTED AND WATER STAINED. REMOVE AND REPLACE THE DAMAGED TRANSITE PANEL FOLLOWING TYPE 1 ASBESTOS PROCEDURES, AS PRESCRIBED UNDER O.REG. 278/05.

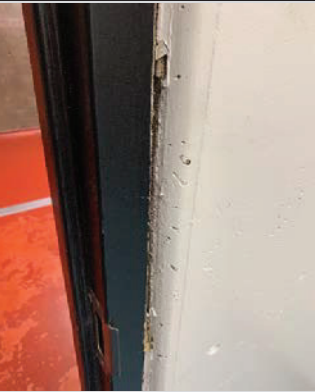
2'x4' ACOUSTIC TILES	LENGTH-WISE FISSURE	CEILING		R-SA11 & R-SA120-(A-F)-06		ND			NO				N/A
		CAULKING	BEIGE CAULKING	DOOR FRAME	2 L.FT.	25622-022-4A-C	2	CHRYSTILE	POOR	A	YES	NON-FRIABLE	SAMPLED BY OHE IN 2022 (PROJECT 25622-022). REMOVE FOLLOWING TYPE 1 ASBESTOS PROCEDURES, AS PRESCRIBED UNDER O.REG. 278/05.

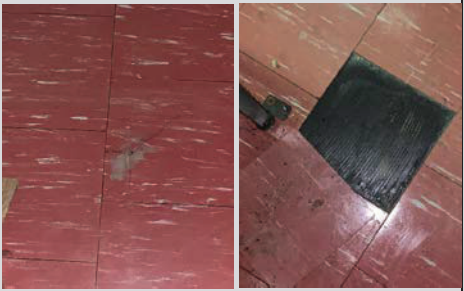
Room Number	Area #	Material	Description	Location	Qty/Unit	SA#	%	Type	Condition	Accessibility	ACM (Yes, No, Suspect)	Friability	Comments	Photographs	Action Required
S253	BIOLOGICAL SCIENCES PREP ROOM	VINYL FLOOR TILES	9x9 RED FLOOR TILES	FLOOR	340 SQ. FT.	R-SA18 & VFT04A-C	2-5	CHRYSTILE	GOOD	A	YES	NON-FRIABLE	SAMPLED BY GOLDER IN 2022 (PROJECT 22521196-1000)		4
		VINYL FLOOR TILES	9x9 RED FLOOR TILES	FLOOR - SPORADIC DAMAGE	6 SQ. FT.	R-SA18 & VFT04A-C	2-5	CHRYSTILE	POOR	A	YES	NON-FRIABLE	ACM DETECTED IN BOTH TILE AND MASTIC. THE DAMAGED ASBESTOS-CONTAINING VINYL FLOOR TILES AND MASTIC SHOULD BE REMOVED FOLLOWING TYPE 1 OR 2 ASBESTOS PROCEDURES, AS PRESCRIBED UNDER O.REG. 278/05.

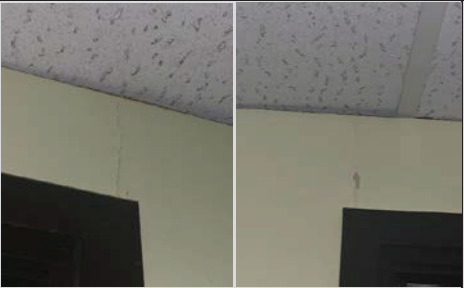
DRYWALL	DRYWALL JOINT COMPOUND	WALL	2 SQ.FT.	DJC05 & 25622-022-5A-C	1	CHRYSTILE	FAIR	A	YES	NON-FRIABLE	REPAIR FOLLOWING TYPE 1 ASBESTOS PROCEDURES AS PRESCRIBED UNDER O.REG. 278/05.

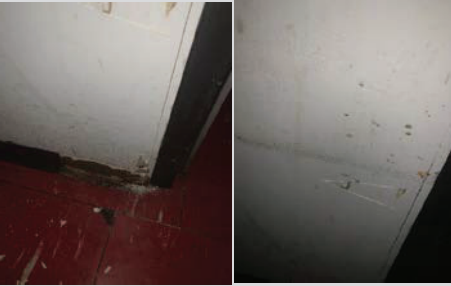
2
		DRYWALL	DRYWALL JOINT COMPOUND	WALL	5 SQ. FT.	25622-022-5A-C	1	CHRYSTILE	POOR	A	YES	NON-FRIABLE	SAMPLED BY OHE IN 2022 (OHE PROJECT 25622-022). DAMAGED ASBESTOS-CONTAINING DRYWALL FINISH SHOULD BE REPAIRED FOLLOWING TYPE 1 ASBESTOS PROCEDURES AS PRESCRIBED UNDER O.REG. 278/05.

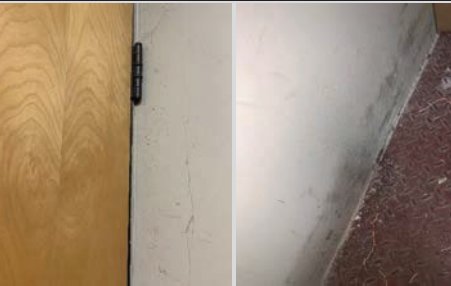
DRYWALL	DRYWALL JOINT COMPOUND	WALL	100 SQ. FT.	DJC05 & 25622-022-5A-C	1	CHRYSTILE	YES	A	YES	NON-FRIABLE	SAMPLED BY GOLDER (PROJECT 22521196-1000) & OHE (PROJECT 25622-022) IN 2022		4
		2'x4' ACOUSTIC TILES	LENGTH-WISE FISSURE	CEILING		R-SA11 & R-SA120-(A-F)-06		ND			NO				N/A
S254A	TELECOM ROOM	DRYWALL	DRYWALL JOINT COMPOUND (BEIGE)	WALL	7 SQ. FT.	25622-022-7A-C	1	CHRYSTILE	POOR	A	YES	NON-FRIABLE	SAMPLED BY OHE IN 2022 (OHE PROJECT #25622-022). DAMAGED ASBESTOS-CONTAINING DRYWALL FINISH SHOULD BE REPAIRED FOLLOWING TYPE 1 ASBESTOS PROCEDURES AS PRESCRIBED UNDER O.REG. 278/05.

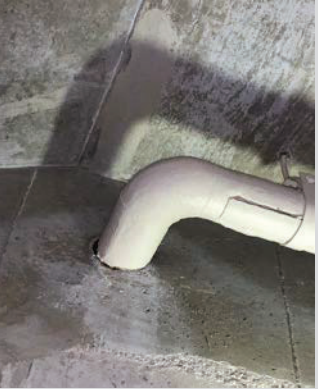
S347	JANITOR CLOSET	NO SUSPECT ACM OBSERVED									NO				N/A
S401S	STAIRWELL	PARGING CEMENT INSULATION ON MECHANICAL PIPE FITTINGS	FITTINGS	CEILING	1	R-SA1	50-75	CHRYSTILE	POOR	C	YES	FRIABLE	PRESENT IN CEILING SPACE. THE DAMAGED ASBESTOS-CONTAINING PARGING CEMENT INSULATION SHOULD BE REMOVED FOLLOWING TYPE 2 GLOVE BAG PROCEDURES, AS PRESCRIBED UNDER O.REG. 278/05.

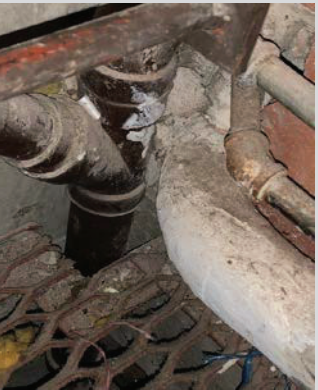
2
		PARGING CEMENT INSULATION ON MECHANICAL PIPE FITTINGS	FITTINGS	IN THE BACK LEFT CORNER AT THE METAL GRATE (FLOOR LEVEL) AT LADDER. DEBRIS ALSO PRESENT IN THE WALL CAVITY	1	R-SA1	50-75	CHRYSTILE	FAIR	C	YES	FRIABLE	THE DAMAGED ASBESTOS-CONTAINING PARGING CEMENT ON FITTING SHOULD BE REPAIRED FOLLOWING TYPE 2 ASBESTOS PROCEDURES, AS PRESCRIBED UNDER O.REG. 278/05.

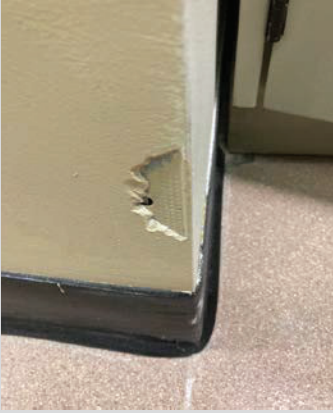
DRYWALL	DRYWALL JOINT COMPOUND	WALL	208 SQ. FT.	R-SA1-F-07	0.5	CHRYSTILE	GOOD	A	YES	NON-FRIABLE			4
		DRYWALL	DRYWALL JOINT COMPOUND	WALL	<1 SQ. FT.	R-SA1-F-07	0.5	CHRYSTILE	FAIR	A	YES	NON-FRIABLE	THE DAMAGED ASBESTOS-CONTAINING DRYWALL FINISH SHOULD BE REPAIRED FOLLOWING TYPE 1 ASBESTOS PROCEDURES, AS PRESCRIBED UNDER O.REG. 278/05.

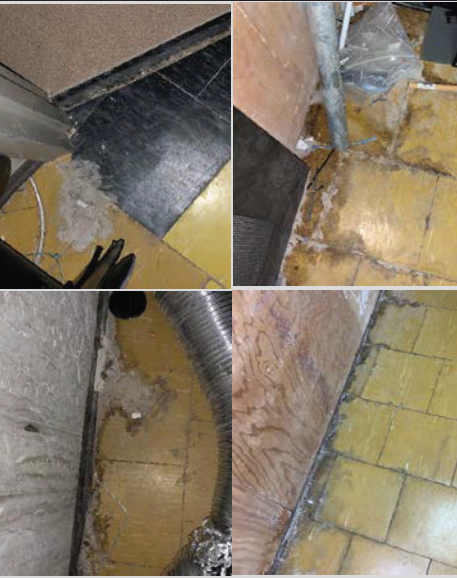
Room Number	Area #	Material	Description	Location	Qty/Unit	SA#	%	Type	Condition	Accessibility	ACM (Yes, No, Suspect)	Friability	Comments	Photographs	Action Required
S507C	SERVER ROOM	VINYL FLOOR TILES	9x9 YELLOW FLOOR TILE	FLOOR	10 SQ. FT.	R-SA43A	5	CHRYSTILE	POOR	A	YES	NON-FRIABLE	ACM DETECTED WITHIN TILE AND MASTIC. THE DAMAGED ASBESTOS-CONTAINING VINYL FLOOR TILES AND MASTIC SHOULD BE REMOVED FOLLOWING TYPE 1 OR 2 ASBESTOS PROCEDURES, AS PRESCRIBED UNDER O.REG. 278/05.

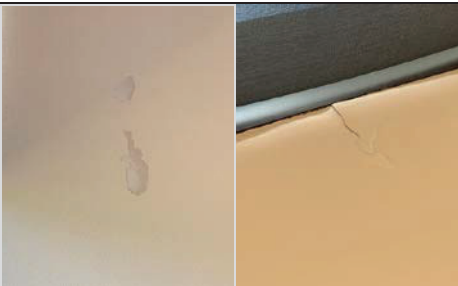
Room Number	Area #	Material	Description	Location	Qty/Unit	SA#	%	Type	Condition	Accessibility	ACM (Yes, No, Suspect)	Friability	Comments	Photographs	Action Required
S511	OFFICE	VINYL SHEET FLOORING	ORANGE/PINK SPECKLED SHEET FLOORING	FLOOR	165 SQ. FT.	R-SA28 & R-SA109-(A-E)-06	1-5	CHRYSTILE	GOOD	A	YES	NON-FRIABLE	ACM DETECTED IN MASTIC ONLY		4
		2'x4' ACOUSTIC TILES	RANDOM PINHOLES	CEILING	90 SQ. FT.	R-SA35 & R-SA122-(A-F)-06		ND			NO				N/A
		TRANSITE ASBESTOS-CEMENT PANEL	TRANSITE(TM) ASBESTOS-CEMENT PANELLING	PERIMETER RADIATOR UNITS							NO		REMOVED IN 2018 (MAPLE PROJECT #16940). TO VIEW PROJECT-SPECIFIC REPORT, SEE FACILITIES AND/OR HEALTH AND SAFETY.		N/A
		DRYWALL	DRYWALL JOINT COMPOUND	WALL	110 SQ. FT.	R-SA1-F-07	0.5	CHRYSTILE	GOOD	A	YES	NON-FRIABLE			4
		DRYWALL	DRYWALL JOINT COMPOUND	WALL	<1 SQ. FT.	R-SA1-F-07	0.5	CHRYSTILE	FAIR	A	YES	NON-FRIABLE	THE DAMAGED ASBESTOS-CONTAINING DRYWALL FINISH SHOULD BE REPAIRED FOLLOWING TYPE 1 ASBESTOS PROCEDURES, AS PRESCRIBED UNDER O.REG. 278/05.

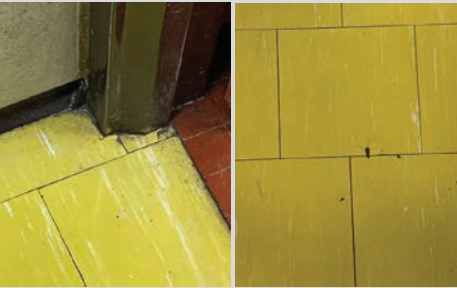
Room Number	Area #	Material	Description	Location	Qty/Unit	SA#	%	Type	Condition	Accessibility	ACM (Yes, No, Suspect)	Friability	Comments	Photographs	Action Required
S522	WOMEN'S WASHROOM	VINYL FLOOR TILES	9x9 YELLOW FLOOR TILE	FLOOR	80 SQ. FT.	R-SA32	5	CHRYSTILE	GOOD	A	YES	NON-FRIABLE	LIMITED ACCESS ABOVE THE DRYWALL CEILING		4
		VINYL FLOOR TILES	9x9 YELLOW FLOOR TILE	FLOOR	2 SQ. FT.	R-SA32	5	CHRYSTILE	POOR	A	YES	NON-FRIABLE	THE DAMAGED ASBESTOS-CONTAINING VINYL FLOOR TILES AND MASTIC SHOULD BE REMOVED FOLLOWING TYPE 1 OR 2 ASBESTOS PROCEDURES, AS PRESCRIBED UNDER O.REG. 278/05.

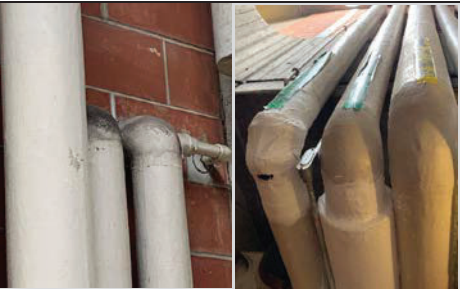
S538B	OFFICE	NO SUSPECT ACM OBSERVED									NO		NO ACCESS ABOVE WOOD PANEL CEILING		N/A
S539	WALK-IN FRIDGE/AUTOCLAVE	NEW LAY-IN CEILING TILES									NO				N/A
S539K	CORRIDOR	2'x4' ACOUSTIC TILES	LENGTH-WISE FISSURE	CEILING		R-SA11 & R-SA120-(A-F)-06		ND			NO				N/A
		PARGING CEMENT INSULATION ON MECHANICAL PIPE FITTINGS	FITTINGS	CEILING SPACE AT STAIRWELL S539S	8	R-SA42	15	CHRYSTILE	GOOD	A	YES	FRIABLE	AT STAIRWELL S539S. REPAIRED IN 2018 (MAPLE PROJECT #16940). TO VIEW PROJECT-SPECIFIC REPORT, SEE FACILITIES AND/OR HEALTH AND SAFETY.		4
S539S	STAIRWELL	PARGING CEMENT INSULATION ON MECHANICAL PIPE FITTINGS	FITTINGS	CEILING SPACE	8	R-SA42	15	CHRYSTILE	POOR	A	YES	FRIABLE	THE DAMAGED (MOULD IMPACTED) ASBESTOS-CONTAINING PARGING CEMENT INSULATION SHOULD BE REMOVED FOLLOWING TYPE 2 GLOVE BAG PROCEDURES, AS PRESCRIBED UNDER O.REG. 278/05.

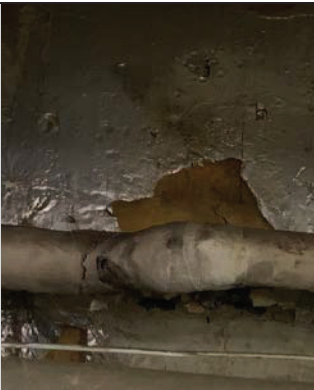
PARGING CEMENT INSULATION ON MECHANICAL PIPE FITTINGS	FITTINGS	GENERAL ROOM	300	R-SA60	50-75	CHRYSTILE	GOOD	B/C	YES	FRIABLE	FITTINGS ASSOCIATED WITH AHU 16 REMOVED IN DEC 2017 (MAPLE PROJECT #16893). TO VIEW PROJECT-SPECIFIC REPORT, SEE FACILITIES AND/OR HEALTH AND SAFETY.		4
		PARGING CEMENT INSULATION ON MECHANICAL PIPE FITTINGS	WATER SOFTENER	GENERAL ROOM	300	R-SA60	50-75	CHRYSTILE	GOOD	B/C	YES	FRIABLE	FITTINGS ASSOCIATED WITH WATER SOFTENER REMOVED IN 2018 (MAPLE PROJECT #16728)		4
		PARGING CEMENT INSULATION ON MECHANICAL PIPE FITTINGS	FITTINGS	GENERAL ROOM	12	R-SA60	50-75	CHRYSTILE	GOOD	B/C	YES	FRIABLE	SELECT FITTINGS REMOVED IN 2019 (MAPLE PROJECT #18098). TO VIEW PROJECT-SPECIFIC REPORT, SEE FACILITIES AND/OR HEALTH AND SAFETY.		4
		PARGING CEMENT INSULATION ON MECHANICAL PIPE FITTINGS	FITTINGS	ACROSS FROM AC09 AT THE VERY END OF THE MECHANICAL ROOM ABOVE DUCTWORK	2	R-SA60	50-75	CHRYSTILE	POOR	B	YES	FRIABLE	THE DAMAGED ASBESTOS-CONTAINING PARGING CEMENT INSULATION SHOULD BE REMOVED FOLLOWING TYPE 2 ASBESTOS PROCEDURES, AS PRESCRIBED UNDER O.REG. 278/05.

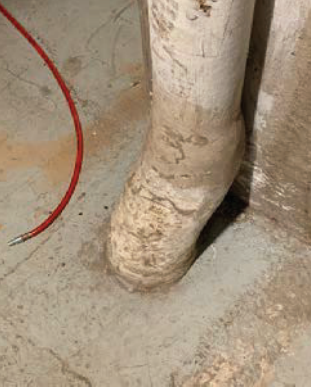
2
		PARGING CEMENT INSULATION ON MECHANICAL PIPE FITTINGS	FITTINGS	ON WALL COLUMN, NEAR DOOR TO SW612	1	R-SA60	50-75	CHRYSTILE	POOR	B	YES	FRIABLE	THE DAMAGED ASBESTOS-CONTAINING PARGING CEMENT INSULATION SHOULD BE REPAIRED FOLLOWING TYPE 2 ASBESTOS PROCEDURES, AS PRESCRIBED UNDER O.REG. 278/05.

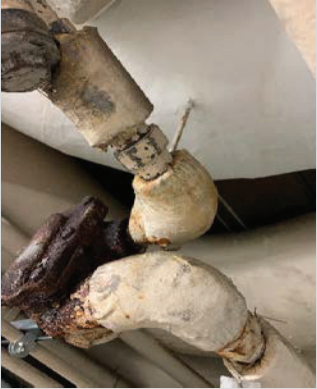
2
		PARGING CEMENT INSULATION ON MECHANICAL PIPE FITTINGS	FITTINGS	NEAR DOOR TO SW612A	1	R-SA60	50-75	CHRYSTILE	POOR	B	YES	FRIABLE	THE DAMAGED ASBESTOS-CONTAINING PARGING CEMENT INSULATION SHOULD BE REPAIRED FOLLOWING TYPE 2 ASBESTOS PROCEDURES, AS PRESCRIBED UNDER O.REG. 278/05.

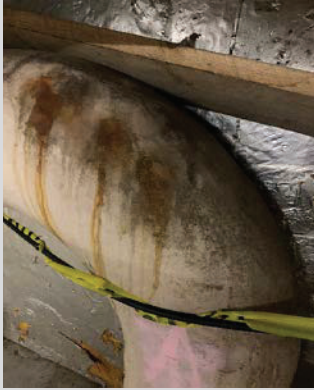
2
		PARGING CEMENT INSULATION ON MECHANICAL PIPE FITTINGS	FITTINGS	NEAR AC #10	1	R-SA60	50-75	CHRYSTILE	POOR	B	YES	FRIABLE	THE DAMAGED ASBESTOS-CONTAINING PARGING CEMENT INSULATION SHOULD BE REPAIRED FOLLOWING TYPE 2 ASBESTOS PROCEDURES, AS PRESCRIBED UNDER O.REG. 278/05.

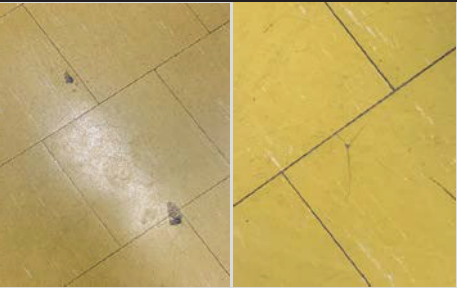
S624	LAB	VINYL FLOOR TILES	9x9 YELLOW FLOOR TILE	FLOOR	300 SQ. FT.	R-SA32	5	CHRYSTILE	GOOD	A	YES	NON-FRIABLE	FLOOR TILES WERE REMOVED DURING RENOVATIONS IN JANUARY AND FEBRUARY 2011. HOWEVER, RESIDUAL AMOUNTS OF THE ASBESTOS-CONTAINING MASTIC MAY REMAIN BENEATH THE NEW, NON-ASBESTOS FLOORING.		4
		DRYWALL		WALL	100 SQ. FT.	SA-34	1.9	CHRYSTILE	GOOD	A	YES	NON-FRIABLE	SAMPLES COLLECTED IN APRIL, 2015.		4
		2'x4' ACOUSTIC TILES	NEW	CEILING							NO		LIMITED VISIBILITY ABOVE CEILING TILES DUE TO DUCTS - NO SUSPECT ACM OBSERVED		N/A
S624A	MAIL ROOM	DRYWALL		INTERIOR & EXTERIOR WALL	350 SQ. FT	SA-34 to SA 35	1.6-1.9	CHRYSTILE	GOOD	A	YES	NON-FRIABLE	SAMPLES COLLECTED IN APRIL, 2015.		4
		VINYL FLOOR TILES	9x9 YELLOW FLOOR TILE	FLOOR	250 SQ. FT.	R-SA32	5	CHRYSTILE	GOOD	A	YES	NON-FRIABLE	PRESUME THE MASTIC IS ALSO ASBESTOS-CONTAINING.		4
		VINYL FLOOR TILES	9x9 YELLOW FLOOR TILE	FLOOR	5 SQ. FT.	R-SA32	5	CHRYSTILE	POOR	A	YES	NON-FRIABLE	PRESUME THE MASTIC IS ALSO ASBESTOS-CONTAINING. THE DAMAGED ASBESTOS-CONTAINING VINYL FLOOR TILES SHOULD BE REMOVED AND REPLACED FOLLOWING TYPE 1 OR 2 ASBESTOS PROCEDURES, AS PRESCRIBED UNDER O.REG. 278/05.

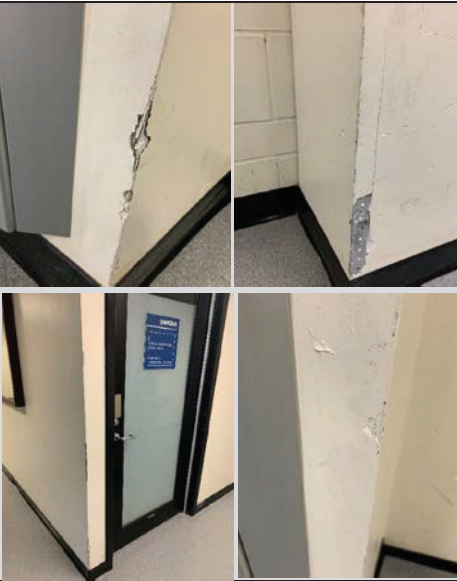
Room Number	Area #	Material	Description	Location	Qty/Unit	SA#	%	Type	Condition	Accessibility	ACM (Yes, No, Suspect)	Friability	Comments	Photographs	Action Required
S625K	CORRIDOR	DRYWALL		WALL	100 SQ. FT.	SA-34	1.9	CHRYSTILE	GOOD	A	YES	NON-FRIABLE	SAMPLES COLLECTED IN APRIL, 2015.		4
		DRYWALL	DRYWALL JOINT COMPOUND	WALL	5 SQ. FT.	SA-34	1.9	CHRYSTILE	POOR	A	YES	NON-FRIABLE	DAMAGED ASBESTOS-CONTAINING DRYWALL FINISH SHOULD BE REPAIRED FOLLOWING TYPE 1 ASBESTOS PROCEDURES AS PRESCRIBED UNDER O.REG. 278/05.

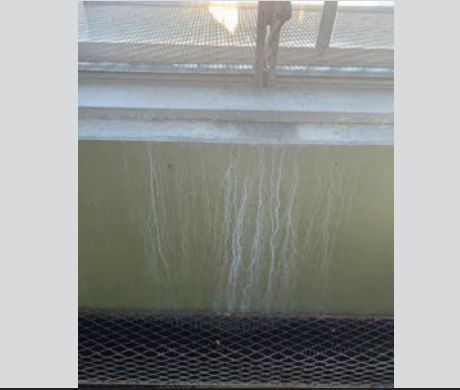
2
		PAINTED TEXTURE COAT OVER PLASTER	PAINTED TEXTURE COAT OVER PLASTER	WALL - ABOVE DOOR		SA 01 (A-G)	ND	ND			NO		SAMPLED FROM VARIOUS LOCATIONS THROUGHOUT THE SCIENCE BUILDING DURING THE 2016 REASSESSMENT.		N/A
		TRANSITE™ ASBESTOS CEMENT	WALL	WALL	50	R-SA22	15-25	CROCIDOLITE	POOR	A	YES	NON-FRIABLE	DURING 2022 REASSESSMENT, TRANSITE ASBESTOS-CEMENT WAS OBSERVED ON THE PERIMETER WALLS OF THE GREENHOUSE. REMOVE FOLLOWING TYPE 1 ASBESTOS PROCEDURES AS PRESCRIBED UNDER O.REG. 278/05
